Manhole Inspection Report

Date:	03/20/2018	Weather:		Coding:	RZMACP
MH#:	M-903-065	Owner:	NA	Len. Surveyed:	2.2
P.O.#:		Surveyor:	John Kuglmaier	Rim to Invert:	3.0
Customer:		Cert. #:	U-1215-07002349	Wall Material:	Concrete (reinforced)

Street:	198' West of Union St. 388' South of	Project:	Hobart, IN
City:	Hobart, IN	GPS Northing:	2912127.421
Location:		GPS Easting:	2912127.421
Drain Area:	Northeast	GPS Accuracy:	Sub-Meter
Cover Shape:	Circular	Evidence of Surcharge:	Yes
Cover Size:	23.0	Potential for Runoff:	None
Comments:

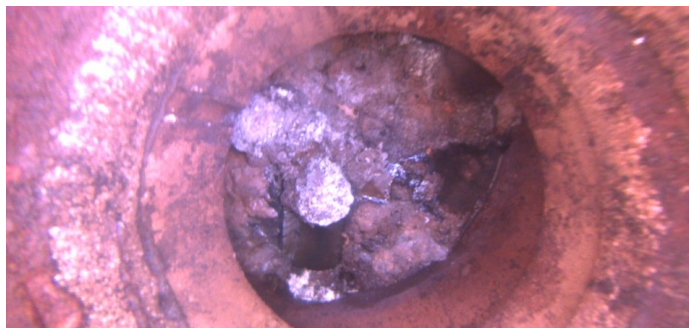
Code: **MGP**
Description: **General Photo**

Distance (ft): **.0**
Structural Grade: **0**
O&M Grade: **0**
Clock Start/From:
Clock To:
1st Value:
2nd Value:
Value Percent:
Step: **NO**
Remarks:

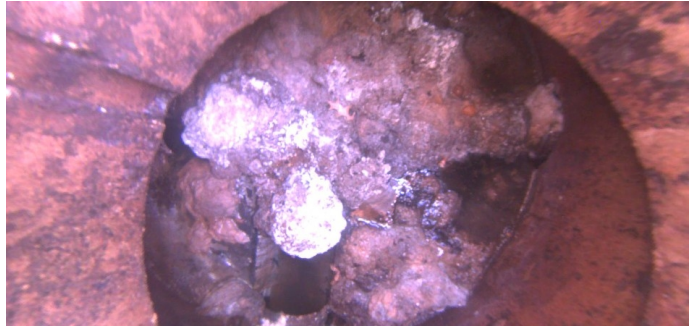
Code: **MGO**
Description: **General Observation**

Distance (ft): **.7**
Structural Grade: **0**
O&M Grade: **0**
Clock Start/From:
Clock To:
1st Value:
2nd Value:
Value Percent:
Step: **NO**
Remarks: **Surcharge**

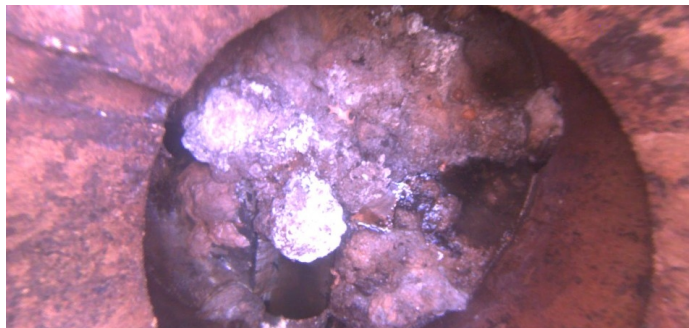
Code: **DAZ**
Description: **Deposits Attached Other**

Distance (ft): **.7**
Structural Grade: **0**
O&M Grade: **4**
Clock Start/From: **12**
Clock To: **12**
1st Value:
2nd Value:
Value Percent: **25.000**
Step: **NO**
Remarks: **Mixed materials**

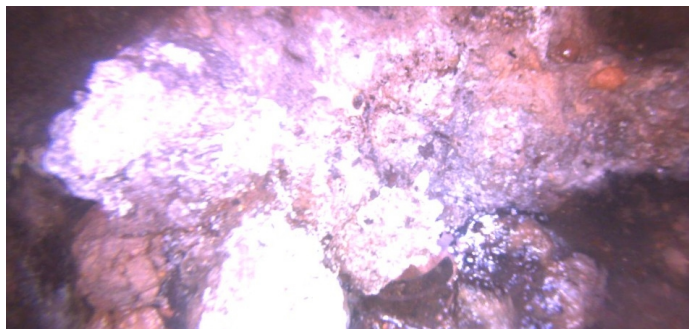
Code: **MGO**
Description: **General Observation**

Distance (ft): **1.8**
Structural Grade: **0**
O&M Grade: **0**
Clock Start/From:
Clock To:
1st Value:
2nd Value:
Value Percent:
Step: **NO**
Remarks: **Ins. Comp.**
