Manhole Inspection Report

Date:	03/20/2018	Weather:		Coding:	RZMACP
MH#:	M-903-066	Owner:	NA	Len. Surveyed:	2.9
P.O.#:		Surveyor:	John Kuglmaier	Rim to Invert:	3.6
Customer:		Cert. #:	U-1215-07002349	Wall Material:	Concrete (reinforced)

Street:	121' West of County Line Rd. 396' S	Project:	Hobart, IN
City:	Hobart, IN	GPS Northing:	2912203.039
Location:		GPS Easting:	2912203.039
Drain Area:	Northeast	GPS Accuracy:	Sub-Meter
Cover Shape:	Circular	Evidence of Surcharge:	Yes
Cover Size:	23.0	Potential for Runoff:	None
Comments:

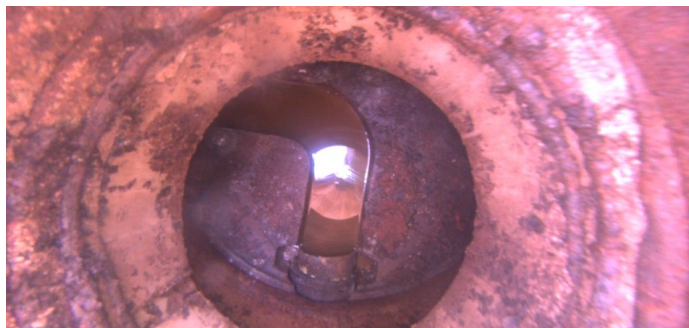
Code: **MGP**
Description: **General Photo**

Distance (ft): **.0**
Structural Grade: **0**
O&M Grade: **0**
Clock Start/From:
Clock To:
1st Value:
2nd Value:
Value Percent:
Step: **NO**
Remarks:

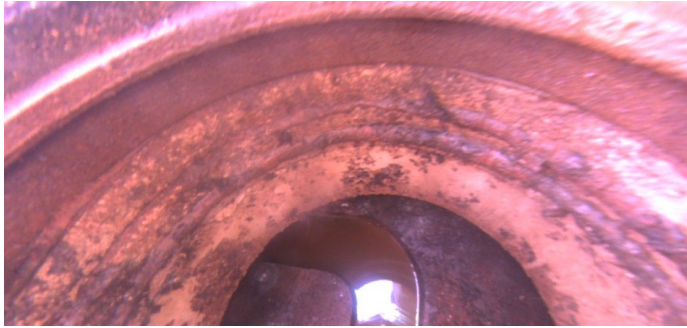
Code:	DAZ
Description:	Deposits Attached Other
Distance (ft):	.0
Structural Grade:	0
O&M Grade:	2
Clock Start/From:	12
Clock To:	12
1st Value:	
2nd Value:	
Value Percent:	5.000
Step:	NO
Remarks:	Mixed materials

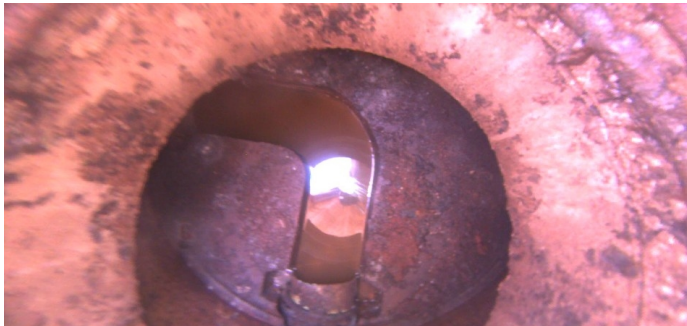
Code:	DAZ
Description:	Deposits Attached Other
Distance (ft):	.5
Structural Grade:	0
O&M Grade:	2
Clock Start/From:	12
Clock To:	12
1st Value:	
2nd Value:	
Value Percent:	5.000
Step:	NO
Remarks:	Mixed materials

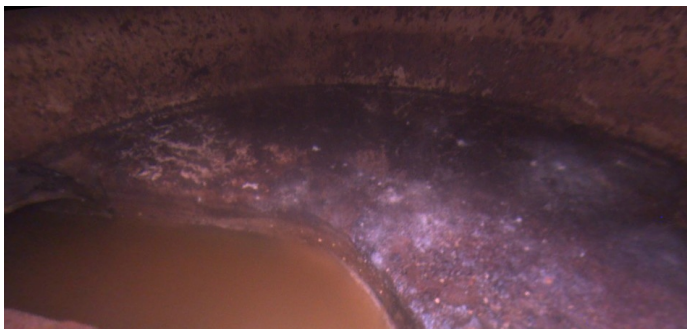
Code:	DAZ
Description:	Deposits Attached Other
Distance (ft):	2.2
Structural Grade:	0
O&M Grade:	2
Clock Start/From:	12
Clock To:	12
1st Value:	
2nd Value:	
Value Percent:	5.000
Step:	NO
Remarks:

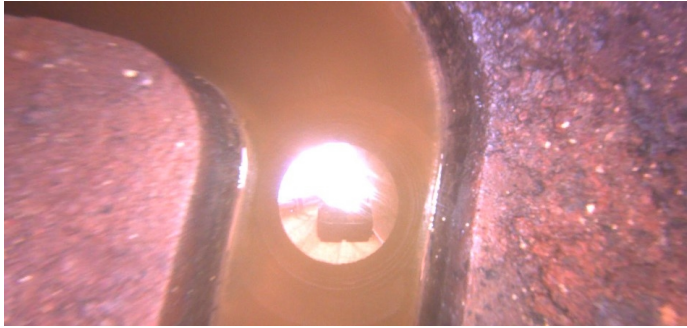
Code:	MGO
Description:	General Observation
Distance (ft):	2.4
Structural Grade:	0
O&M Grade:	0
Clock Start/From:	
Clock To:	
1st Value:	
2nd Value:	
Value Percent:	
Step:	NO
Remarks:	Ins. Comp.
