Manhole Inspection Report

Date:	03/28/2018	Weather:		Coding:	RZMACP
MH#:	M-903-068	Owner:	NA	Len. Surveyed:	3.3
P.O.#:		Surveyor:	John Kuglmaier	Rim to Invert:	4.5
Customer:		Cert. #:	U-1215-07002349	Wall Material:	Concrete (reinforced)

Street:	The West Side of Shelby St. 597' Sou	Project:	Hobart, IN
City:	Hobart, IN	GPS Northing:	0.0
Location:		GPS Easting:	0.0
Drain Area:	Northeast	GPS Accuracy:	Nearest Meter
Cover Shape:	Circular	Evidence of Surcharge:	No
Cover Size:	23.0	Potential for Runoff:	None
Comments:

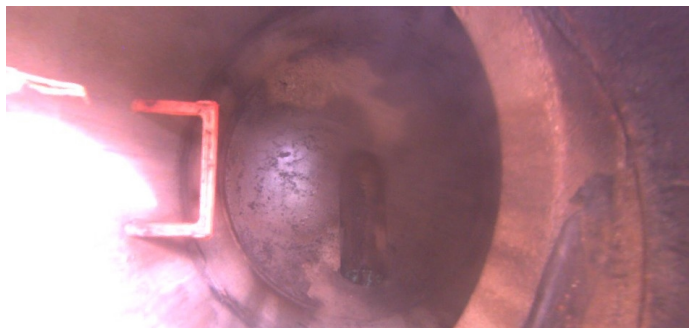
Code: **MGP**
Description: **General Photo**

Distance (ft): **.0**
Structural Grade: **0**
O&M Grade: **0**
Clock Start/From:
Clock To:
1st Value:
2nd Value:
Value Percent:
Step: **NO**
Remarks:

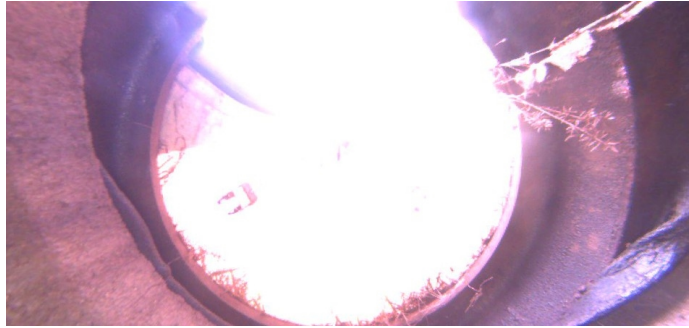
Code: **MGP**
Description: **General Photo**

Distance (ft): **1.5**
Structural Grade: **0**
O&M Grade: **0**
Clock Start/From:
Clock To:
1st Value:
2nd Value:
Value Percent:
Step: **NO**
Remarks:

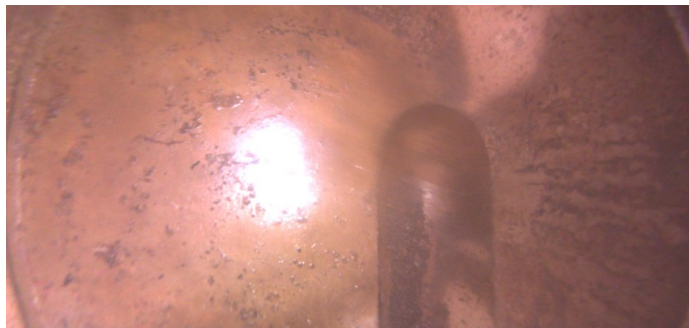
Code: **MGO**
Description: **General Observation**

Distance (ft): **2.6**
Structural Grade: **0**
O&M Grade: **0**
Clock Start/From:
Clock To:
1st Value:
2nd Value:
Value Percent:
Step: **NO**
Remarks: **Ins. Comp.**
