# Manhole Inspection Report

| MH#: | M-904-001 | Owner: | NA | Len. Surveyed: | 7.9 |

| Street: | Union St. 484' South of Home Ave. | Project: | Hobart, IN |

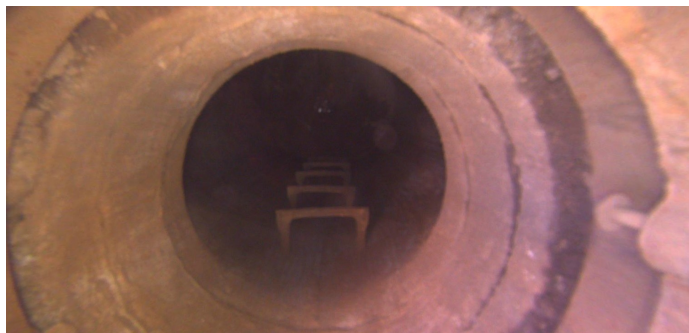
Code: **MGP**  
Description: **General Photo**

Distance (ft): **.0**  
Structural Grade: **0**  
O&M Grade: **0**  
Clock Start/From:  
Clock To:  
1st Value:  
2nd Value:  
Value Percent:  
Step: **NO**  
Remarks: **ACCESS MH**

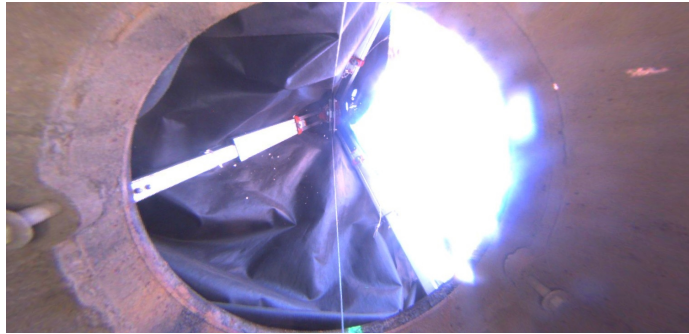
Code: **MGO**  
Description: **General Observation**

Distance (ft): **1.3**  
Structural Grade: **0**  
O&M Grade: **0**  
Clock Start/From:  
Clock To:  
1st Value:  
2nd Value:  
Value Percent:  
Step: **NO**  
Remarks: **UNDERSIDE OF FRAME**

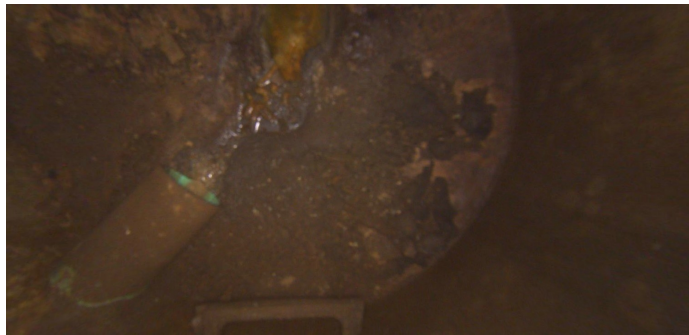
| | Position | Code | Observation | Video (sec) | Grade |
|--|---|---|---|---|---|
| | 6.4 | DSF | Deposits Settled Fine | 49 | M 2 |

Code: **DSF**  
Description: **Deposits Settled Fine**

Distance (ft): **6.4**  
Structural Grade: **0**  
O&M Grade: **2**  
Clock Start/From: **12**  
Clock To: **12**  
1st Value:  
2nd Value:  
Value Percent: **5.000**  
Step: **NO**  
Remarks:

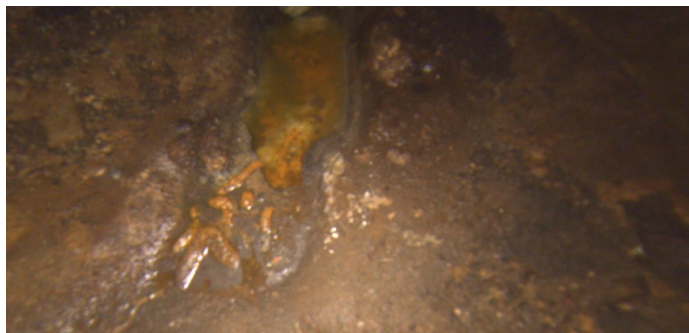
Code: **MGO**  
Description: **General Observation**

Distance (ft): **7.9**  
Structural Grade: **0**  
O&M Grade: **0**  
Clock Start/From:  
Clock To:  
1st Value:  
2nd Value:  
Value Percent:  
Step: **NO**  
Remarks: **END SURVEY**
