Manhole Inspection Report

| MH#: | M-904-002 | Owner: | NA | Len. Surveyed: | 8.3 |

| Street: | Union St. 246' South of Home Ave. | Project: | Hobart, IN |

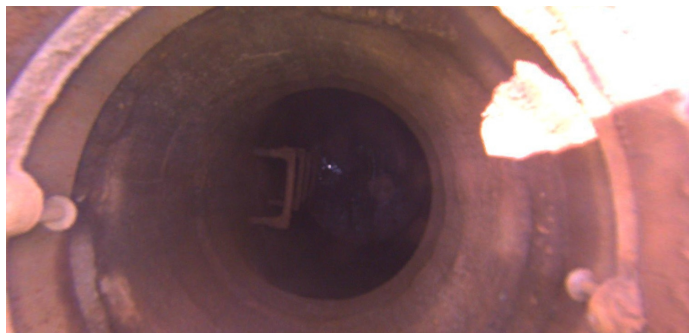
Code: **MGP**
Description: **General Photo**

Distance (ft): **.0**
Structural Grade: **0**
O&M Grade: **0**
Clock Start/From:
Clock To:
1st Value:
2nd Value:
Value Percent:
Step: **NO**
Remarks: **ACCESS MH**

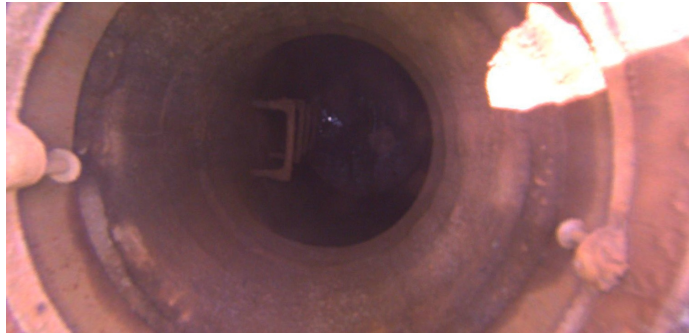
Code: **MGP**
Description: **General Photo**

Distance (ft): **.0**
Structural Grade: **0**
O&M Grade: **0**
Clock Start/From:
Clock To:
1st Value:
2nd Value:
Value Percent:
Step: **NO**
Remarks: **ACCESS MH**

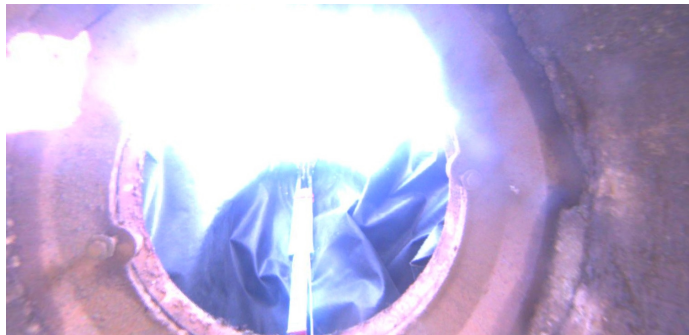
Code: **MGO**
Description: **General Observation**

Distance (ft): **2.3**
Structural Grade: **0**
O&M Grade: **0**
Clock Start/From:
Clock To:
1st Value:
2nd Value:
Value Percent:
Step: **NO**
Remarks: **UNDERSIDE OF FRAME**

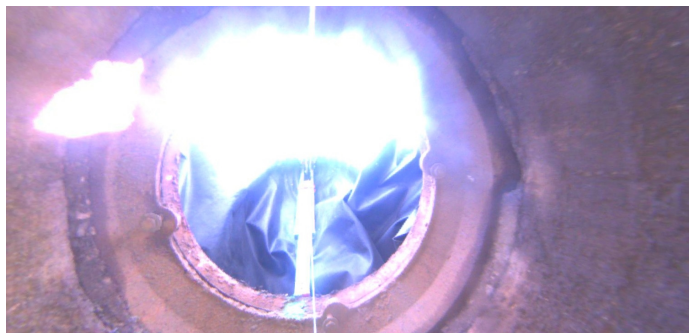
Code: **MGP**
Description: **General Photo**

Distance (ft): **2.5**
Structural Grade: **0**
O&M Grade: **0**
Clock Start/From:
Clock To:
1st Value:
2nd Value:
Value Percent:
Step: **NO**
Remarks: **UNDERSIDE OF FRAME**

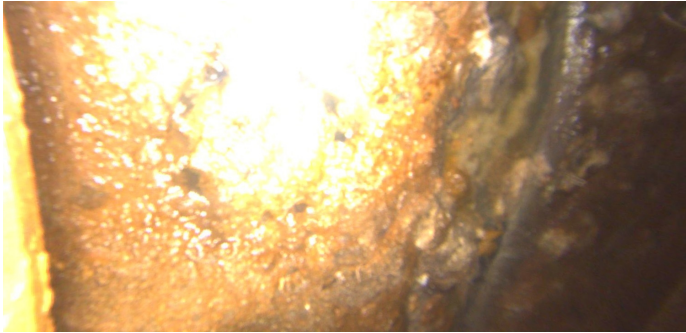
| Code: | MGO |

| Remarks: | END SURVEY |
