Manhole Inspection Report

Date:	05/08/2018	Weather:		Coding:	RZMACP
MH#:	M-904-003	Owner:	NA	Len. Surveyed:	8.5
P.O.#:		Surveyor:	Jen Costello	Rim to Invert:	9.5
Customer:		Cert. #:	U-907-5518	Wall Material:	Concrete (reinforced)

Street:	Union St. 60' North of Home Ave.	Project:	Hobart, IN
City:	Hobart, IN	GPS Northing:	2912401.085
Location:		GPS Easting:	2912401.085
Drain Area:	Northeast	GPS Accuracy:	Sub-Meter
Cover Shape:	Circular	Evidence of Surcharge:	No
Cover Size:	22.5	Potential for Runoff:	None
Comments:

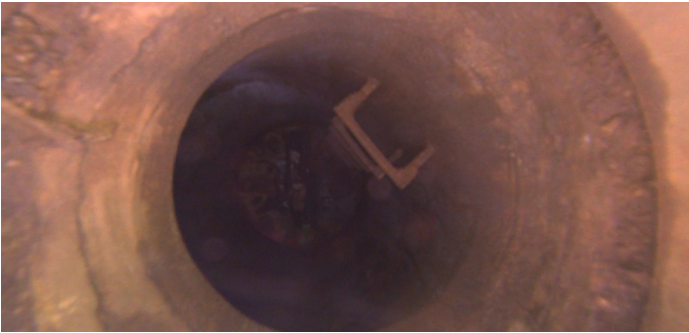
Code: **MGP**
 Description: **General Photo**

Distance (ft): **.0**
 Structural Grade: **0**
 O&M Grade: **0**
 Clock Start/From:
 Clock To:
 1st Value:
 2nd Value:
 Value Percent:
 Step: **NO**
 Remarks: **ACCESS MH**

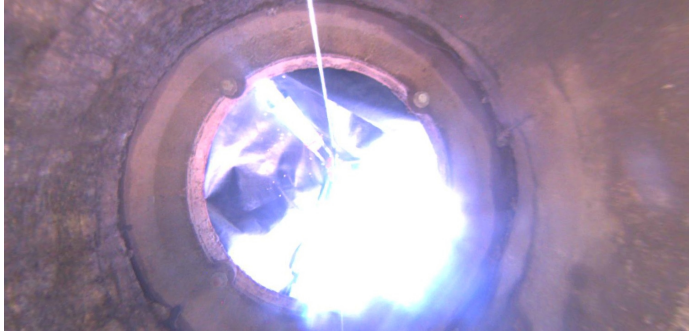
Code:	MGO
Description:	General Observation
Distance (ft):	2.5
Structural Grade:	0
O&M Grade:	0
Clock Start/From:	
Clock To:	
1st Value:	
2nd Value:	
Value Percent:	
Step:	NO
Remarks:	UNDERSIDE OF FRAME

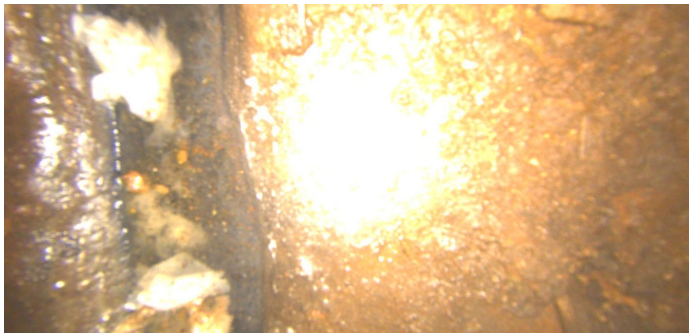
Code:	MGO
Description:	General Observation
Distance (ft):	8.5
Structural Grade:	0
O&M Grade:	0
Clock Start/From:	
Clock To:	
1st Value:	
2nd Value:	
Value Percent:	
Step:	NO
Remarks:	END SURVEY
