Manhole Inspection Report

| MH#: | M-904-008 | Owner: | NA | Len. Surveyed: | 14.5 |

| Street: | North of Fraser Ln. 763' West of Uni | Project: | Hobart, IN |

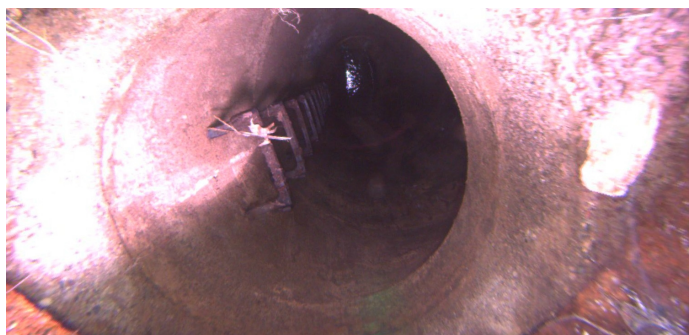
Code: **MGO**
Description: **General Observation**

Distance (ft): **.0**
Structural Grade: **0**
O&M Grade: **0**
Clock Start/From:
Clock To:
1st Value:
2nd Value:
Value Percent:
Step: **NO**
Remarks: **access MH**

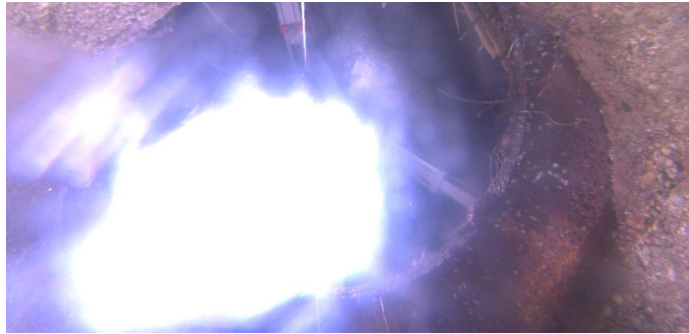
| Description: | General Observation |
| Distance (ft): | 1.8 |
| Remarks: | UNDERSIDE OF FRAME |

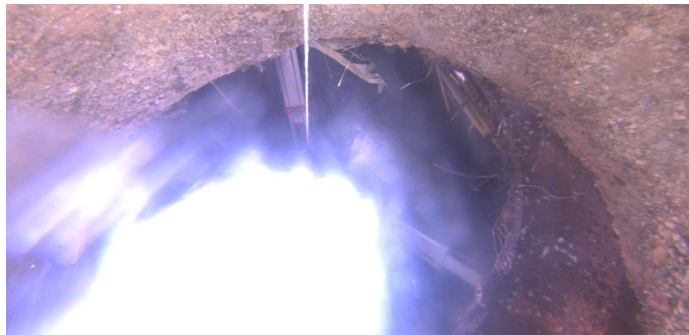
| Description: | Surface Aggregate Visible |
| Distance (ft): | 1.8 |
| Structural Grade: | 3 |
| Clock Start/From: | 12 |

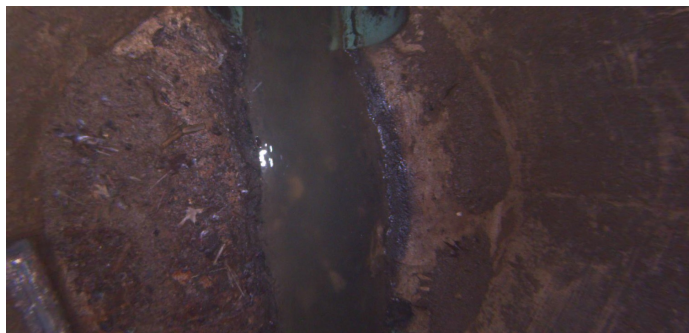
| Description: | Deposits Settled Fine |
| Distance (ft): | 12.5 |
| O&M Grade: | 2 |
| Value Percent: | 5.000 |

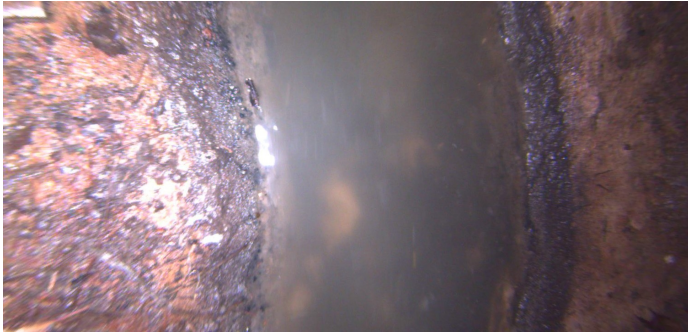
| Description: | General Observation |
| Distance (ft): | 14.3 |
| Remarks: | END SURVEY |
