Manhole Inspection Report

Date:	05/11/2018	Weather:		Coding:	RZMACP
MH#:	M-904-012	Owner:	NA	Len. Surveyed:	13.4
P.O.#:		Surveyor:	Jen Costello	Rim to Invert:	15.0
Customer:		Cert. #:	U-907-5518	Wall Material:	Concrete (reinforced)

Street:	Fraser Ln. to the Northwest.	Project:	Hobart, IN
City:	Hobart, IN	GPS Northing:	2911289.039
Location:		GPS Easting:	2911289.039
Drain Area:	Northeast	GPS Accuracy:	Sub-Meter
Cover Shape:	Circular	Evidence of Surcharge:	No
Cover Size:	22.5	Potential for Runoff:	None
Comments:

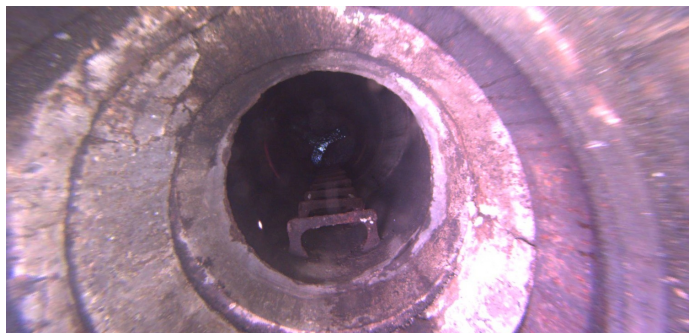
Code: **MGO**
Description: **General Observation**

Distance (ft): **.0**
Structural Grade: **0**
O&M Grade: **0**
Clock Start/From:
Clock To:
1st Value:
2nd Value:
Value Percent:
Step: **NO**
Remarks: **ACCESS MH**

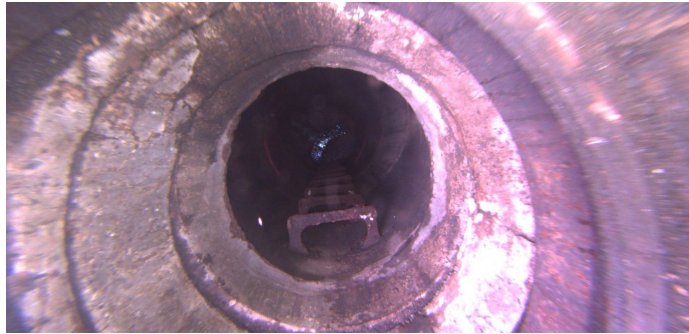
Code: **FM**
Description: **Fracture Multiple**

Distance (ft): **.0**
Structural Grade: **4**
O&M Grade: **0**
Clock Start/From: **10**
Clock To: **4**
1st Value:
2nd Value:
Value Percent:
Step: **NO**
Remarks:

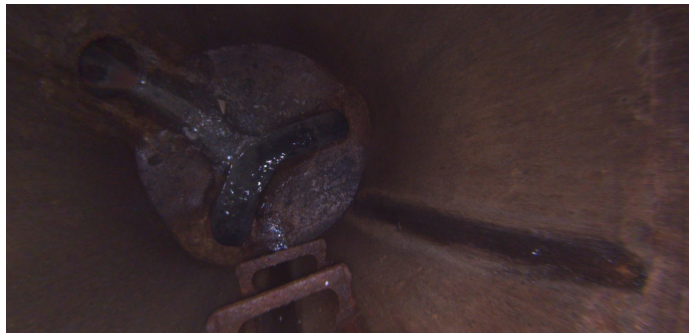
Code: **IW**
Description: **Infil Weeper**

Distance (ft): **10.0**
Structural Grade: **0**
O&M Grade: **2**
Clock Start/From: **8**
Clock To: **6**
1st Value:
2nd Value:
Value Percent:
Step: **NO**
Remarks:

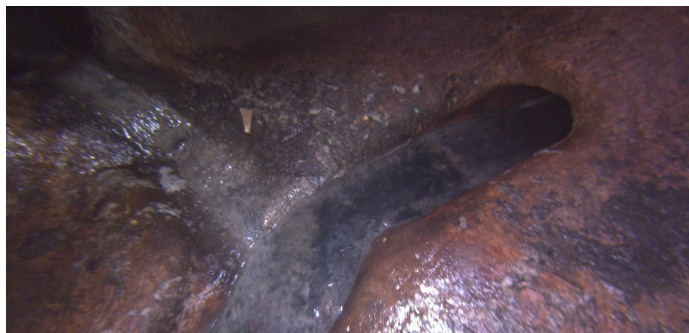
Code: **MGO**
Description: **General Observation**

Distance (ft): **13.4**
Structural Grade: **0**
O&M Grade: **0**
Clock Start/From:
Clock To:
1st Value:
2nd Value:
Value Percent:
Step: **NO**
Remarks: **END SURVEY**
