# Manhole Inspection Report

Date:	05/08/2018	Weather:		Coding:	RZMACP
MH#:	M-904-021	Owner:	NA	Len. Surveyed:	5.6
P.O.#:		Surveyor:	Jen Costello	Rim to Invert:	6.2
Customer:		Cert. #:	U-907-5518	Wall Material:	Concrete (reinforced)

Street:	Fraser St. West. 181' North of Clevel	Project:	Hobart, IN
City:	Hobart, IN	GPS Northing:	2911283.613
Location:		GPS Easting:	2911283.613
Drain Area:	Northeast	GPS Accuracy:	Sub-Meter
Cover Shape:	Circular	Evidence of Surcharge:	No
Cover Size:	22.5	Potential for Runoff:	None
Comments:

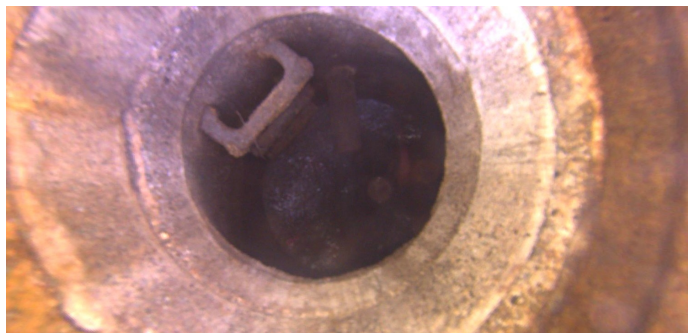
Code: **MGP**  
Description: **General Photo**

Distance (ft): **.0**  
Structural Grade: **0**  
O&M Grade: **0**  
Clock Start/From:  
Clock To:  
1st Value:  
2nd Value:  
Value Percent:  
Step: **NO**  
Remarks: **ACCESS MH**

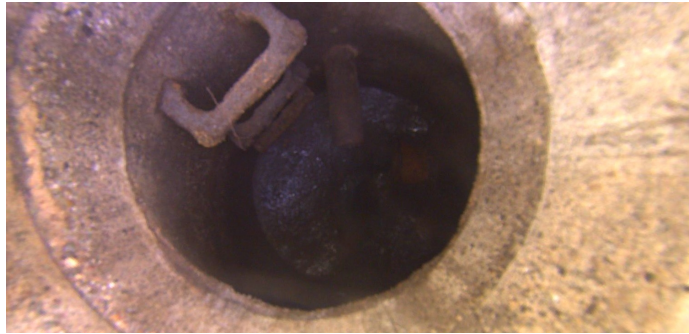
Code: **SAV**  
Description: **Surface Aggregate Visible**

Distance (ft): **.5**  
Structural Grade: **3**  
O&M Grade: **0**  
Clock Start/From: **12**  
Clock To: **12**  
1st Value:  
2nd Value:  
Value Percent:  
Step: **NO**  
Remarks:

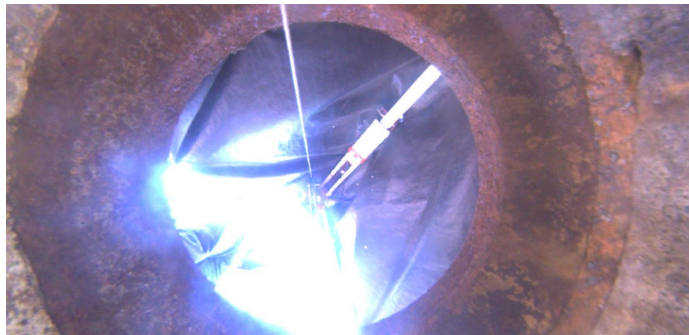
Code: **MGO**  
Description: **General Observation**

Distance (ft): **1.9**  
Structural Grade: **0**  
O&M Grade: **0**  
Clock Start/From:  
Clock To:  
1st Value:  
2nd Value:  
Value Percent:  
Step: **NO**  
Remarks: **UNDERSIDE OF FRAME**

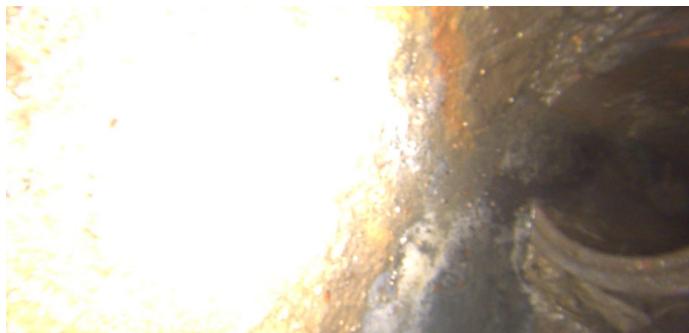
Code: **MGO**  
Description: **General Observation**

Distance (ft): **5.6**  
Structural Grade: **0**  
O&M Grade: **0**  
Clock Start/From:  
Clock To:  
1st Value:  
2nd Value:  
Value Percent:  
Step: **NO**  
Remarks: **END SURVEY**
