# Manhole Inspection Report

Date:	05/09/2018	Weather:		Coding:	RZMACP
MH#:	M-904-024	Owner:	NA	Len. Surveyed:	3.1
P.O.#:		Surveyor:	Jen Costello	Rim to Invert:	2.9
Customer:		Cert. #:	U-907-5518	Wall Material:	Concrete (reinforced)

Street:	Cleveland Ave. 198' East of Clevelan	Project:	Hobart, IN
City:	Hobart, IN	GPS Northing:	41.53136063
Location:		GPS Easting:	-87.2362442
Drain Area:	Northeast	GPS Accuracy:	Nearest Meter
Cover Shape:	Circular	Evidence of Surcharge:	No
Cover Size:	22.5	Potential for Runoff:	None
Comments:

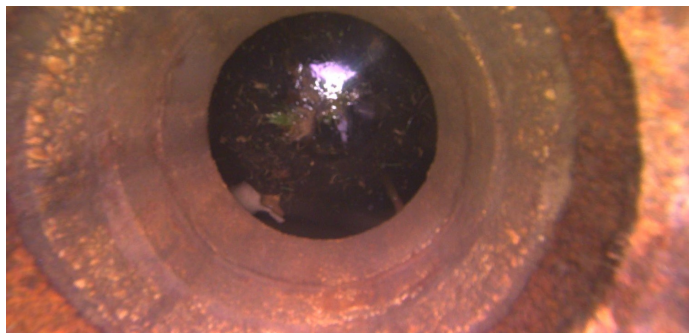
Code: **MGO**  
Description: **General Observation**

Distance (ft): **.0**  
Structural Grade: **0**  
O&M Grade: **0**  
Clock Start/From:  
Clock To:  
1st Value:  
2nd Value:  
Value Percent:  
Step: **NO**  
Remarks: **ACCESS MH**

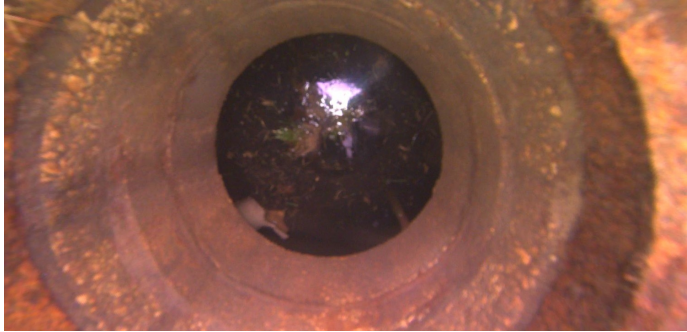
Code:	<b>SAV</b>
Description:	<b>Surface Aggregate Visible</b>
Distance (ft):	<b>.0</b>
Structural Grade:	<b>3</b>
O&M Grade:	<b>0</b>
Clock Start/From:	<b>12</b>
Clock To:	<b>12</b>
1st Value:	
2nd Value:	
Value Percent:	
Step:	<b>NO</b>
Remarks:

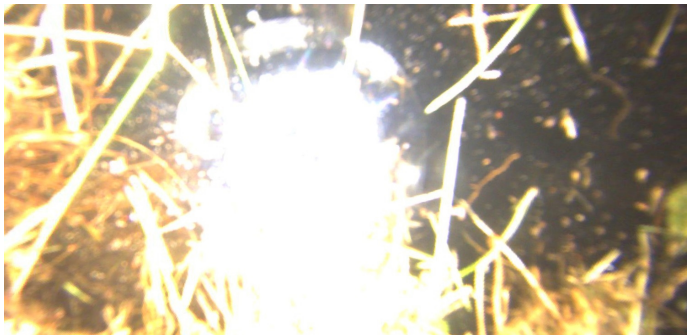
Code:	<b>MGO</b>
Description:	<b>General Observation</b>
Distance (ft):	<b>3.1</b>
Structural Grade:	<b>0</b>
O&M Grade:	<b>0</b>
Clock Start/From:	
Clock To:	
1st Value:	
2nd Value:	
Value Percent:	
Step:	<b>NO</b>
Remarks:	<b>END SURVEY</b>
