Manhole Inspection Report

Date:	05/07/2018	Weather:		Coding:	RZMACP
MH#:	M-904-025	Owner:	NA	Len. Surveyed:	6.2
P.O.#:		Surveyor:	Jen Costello	Rim to Invert:	7.3
Customer:		Cert. #:	U-907-5518	Wall Material:	Concrete (reinforced)

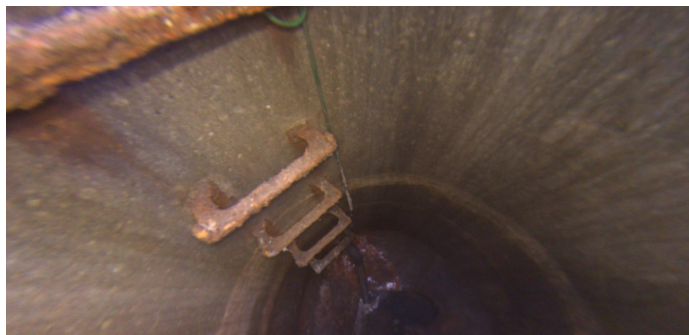
Code: **MGO**
Description: **General Observation**

Distance (ft): **1.2**
Structural Grade: **0**
O&M Grade: **0**
Clock Start/From:
Clock To:
1st Value:
2nd Value:
Value Percent:
Step: **NO**
Remarks: **UNDERSIDE OF FRAME**

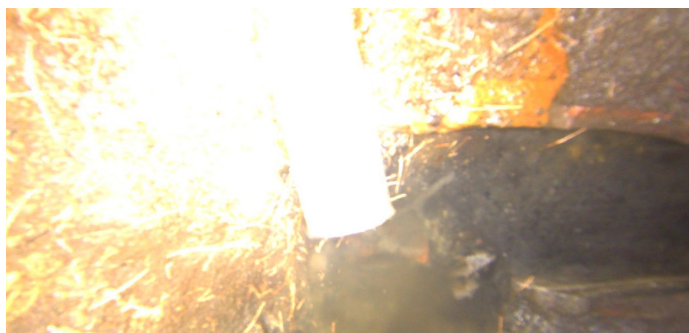
Code: **OBZ**
Description: **Obstacle Other**

Distance (ft): **1.2**
Structural Grade: **0**
O&M Grade: **2**
Clock Start/From: **12**
Clock To:
1st Value:
2nd Value:
Value Percent: **5.000**
Step: **NO**
Remarks: **TWINE**
