# Manhole Inspection Report

Date:	05/07/2018	Weather:		Coding:	RZMACP
MH#:	M-904-031	Owner:	NA	Len. Surveyed:	9.0
P.O.#:		Surveyor:	Jen Costello	Rim to Invert:	9.0
Customer:		Cert. #:	U-907-5518	Wall Material:	Concrete (reinforced)

Street:	Cleveland Terrace. 331' North of Cle	Project:	Hobart, IN
City:	Hobart, IN	GPS Northing:	2910802.739
Location:		GPS Easting:	2910802.739
Drain Area:	Northeast	GPS Accuracy:	Sub-Meter
Cover Shape:	Circular	Evidence of Surcharge:	No
Cover Size:	22.5	Potential for Runoff:	None
Comments:

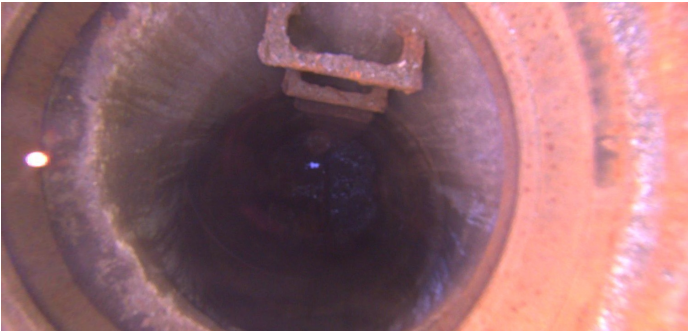
Code:	MGP
Description:	General Photo
Distance (ft):	.0
Structural Grade:	0
O&M Grade:	0
Clock Start/From:	
Clock To:	
1st Value:	
2nd Value:	
Value Percent:	
Step:	NO
Remarks:	ACCESS MH

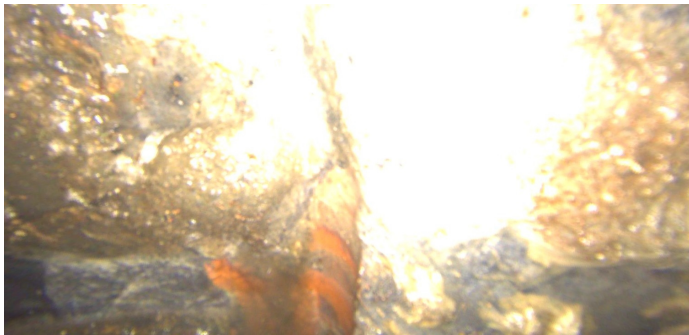
Code:	<b>MGO</b>
Description:	<b>General Observation</b>
Distance (ft):	<b>9.0</b>
Structural Grade:	<b>0</b>
O&M Grade:	<b>0</b>
Clock Start/From:	
Clock To:	
1st Value:	
2nd Value:	
Value Percent:	
Step:	<b>NO</b>
Remarks:	<b>END SURVEY</b>
