Manhole Inspection Report

Date:	05/07/2018	Weather:		Coding:	RZMACP
MH#:	M-904-032	Owner:	NA	Len. Surveyed:	7.0
P.O.#:		Surveyor:	Jen Costello	Rim to Invert:	7.2
Customer:		Cert. #:	U-907-5518	Wall Material:	Concrete (reinforced)

Street:	East Cleveland Terrace. 320' North o	Project:	Hobart, IN
City:	Hobart, IN	GPS Northing:	2910915.165
Location:		GPS Easting:	2910915.165
Drain Area:	Northeast	GPS Accuracy:	Sub-Meter
Cover Shape:	Circular	Evidence of Surcharge:	No
Cover Size:	22.5	Potential for Runoff:	None
Comments:

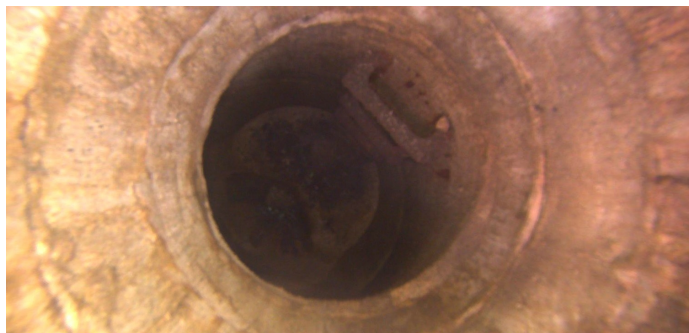
Code: **MGO**
Description: **General Observation**

Distance (ft): **.0**
Structural Grade: **0**
O&M Grade: **0**
Clock Start/From:
Clock To:
1st Value:
2nd Value:
Value Percent:
Step: **NO**
Remarks: **access mh**

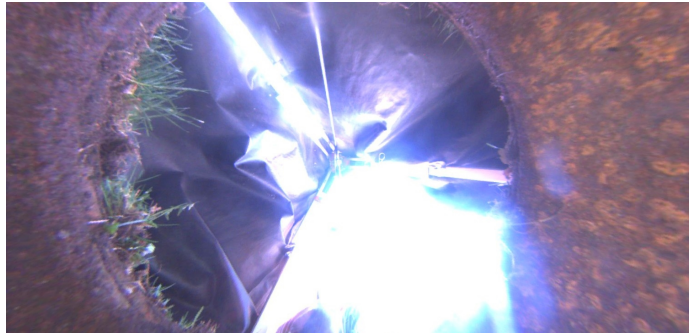
Code:	MGO
Description:	General Observation
Distance (ft):	1.1
Structural Grade:	0
O&M Grade:	0
Clock Start/From:	
Clock To:	
1st Value:	
2nd Value:	
Value Percent:	
Step:	NO
Remarks:	underside of frame

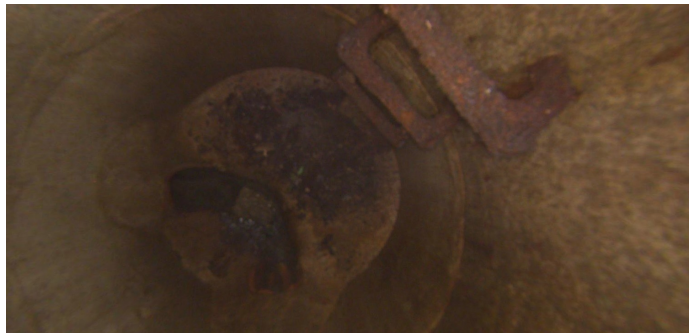
Code:	SAV
Description:	Surface Aggregate Visible
Distance (ft):	2.4
Structural Grade:	3
O&M Grade:	0
Clock Start/From:	12
Clock To:	12
1st Value:	
2nd Value:	
Value Percent:	
Step:	NO
Remarks:

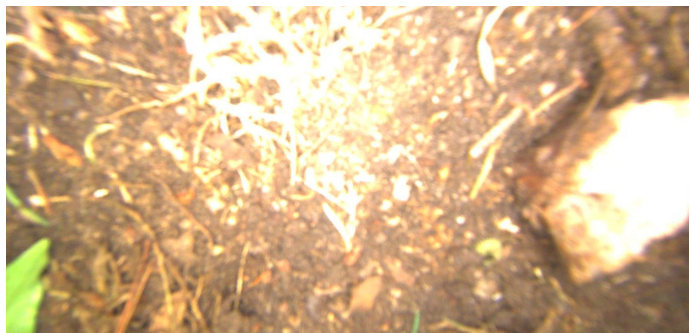
Code:	DSF
Description:	Deposits Settled Fine
Distance (ft):	7.0
Structural Grade:	0
O&M Grade:	2
Clock Start/From:	12
Clock To:	6
1st Value:	
2nd Value:	
Value Percent:	5.000
Step:	NO
Remarks:

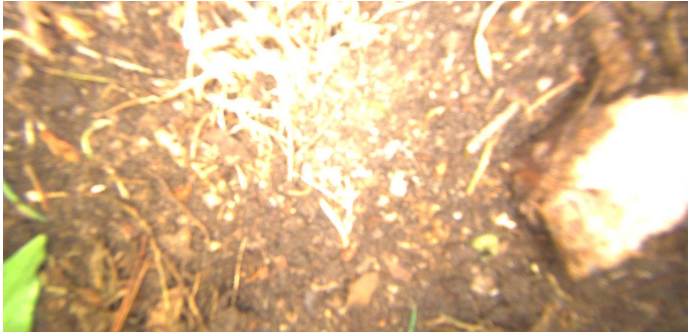
Code:	MGO
Description:	General Observation
Distance (ft):	7.0
Structural Grade:	0
O&M Grade:	0
Clock Start/From:	
Clock To:	
1st Value:	
2nd Value:	
Value Percent:	
Step:	NO
Remarks:	end survey
