Manhole Inspection Report

Date:	05/07/2018	Weather:		Coding:	RZMACP
MH#:	M-904-033	Owner:	NA	Len. Surveyed:	6.3
P.O.#:		Surveyor:	Jen Costello	Rim to Invert:	6.8
Customer:		Cert. #:	U-907-5518	Wall Material:	Concrete (reinforced)

Street:	E. Cleveland Terrace. 578' North of C	Project:	Hobart, IN
City:	Hobart, IN	GPS Northing:	2910906.524
Location:		GPS Easting:	2910906.524
Drain Area:	Northeast	GPS Accuracy:	Sub-Meter
Cover Shape:	Circular	Evidence of Surcharge:	No
Cover Size:	22.5	Potential for Runoff:	None
Comments:

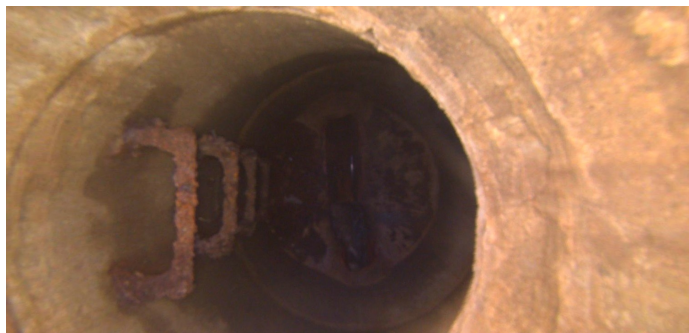
Code: **MGP**
Description: **General Photo**

Distance (ft): **.0**
Structural Grade: **0**
O&M Grade: **0**
Clock Start/From:
Clock To:
1st Value:
2nd Value:
Value Percent:
Step: **NO**
Remarks: **ACCESS MH**

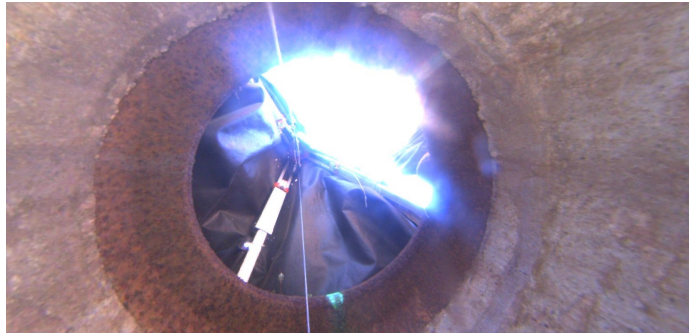
Code: **MGO**
Description: **General Observation**

Distance (ft): **1.6**
Structural Grade: **0**
O&M Grade: **0**
Clock Start/From:
Clock To:
1st Value:
2nd Value:
Value Percent:
Step: **NO**
Remarks: **UNDERSIDE OF FRAME**

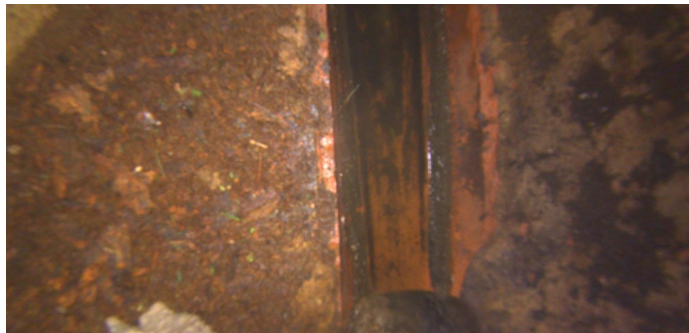
Code: **DSF**
Description: **Deposits Settled Fine**

Distance (ft): **5.2**
Structural Grade: **0**
O&M Grade: **2**
Clock Start/From: **6**
Clock To: **12**
1st Value:
2nd Value:
Value Percent: **5.000**
Step: **NO**
Remarks:

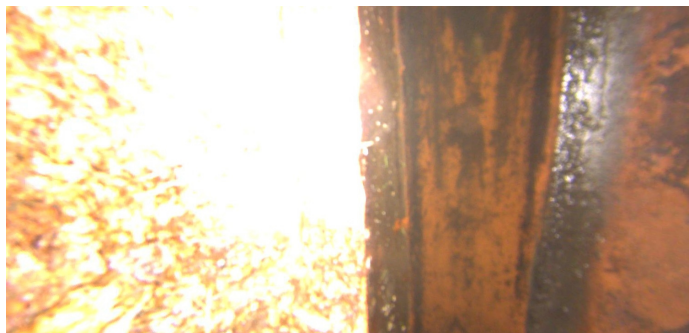
Code: **MGO**
Description: **General Observation**

Distance (ft): **6.3**
Structural Grade: **0**
O&M Grade: **0**
Clock Start/From:
Clock To:
1st Value:
2nd Value:
Value Percent:
Step: **NO**
Remarks: **END SURVEY**
