# Manhole Inspection Report

Date:	05/15/2018	Weather:		Coding:	RZMACP
MH#:	M-904-036	Owner:	NA	Len. Surveyed:	5.3
P.O.#:		Surveyor:	Jen Costello	Rim to Invert:	6.2
Customer:		Cert. #:	U-907-5518	Wall Material:	Concrete (reinforced)

Street:	Clev. Terrace St. to the North.	Project:	Hobart, IN
City:	Hobart, IN	GPS Northing:	2910901.768
Location:		GPS Easting:	2910901.768
Drain Area:	Northeast	GPS Accuracy:	Sub-Meter
Cover Shape:	Circular	Evidence of Surcharge:	No
Cover Size:	22.5	Potential for Runoff:	None
Comments:

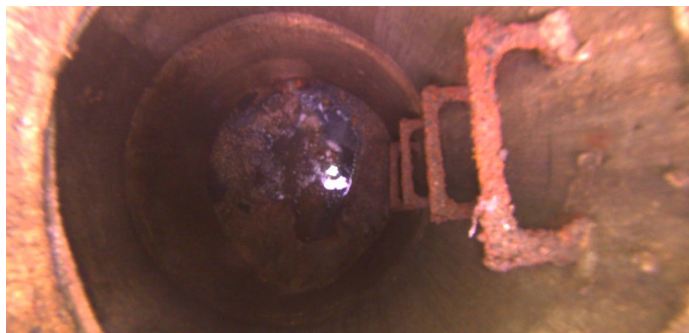
Code: **MGP**  
Description: **General Photo**

Distance (ft): **.0**  
Structural Grade: **0**  
O&M Grade: **0**  
Clock Start/From:  
Clock To:  
1st Value:  
2nd Value:  
Value Percent:  
Step: **NO**  
Remarks: **ACCESS MH**

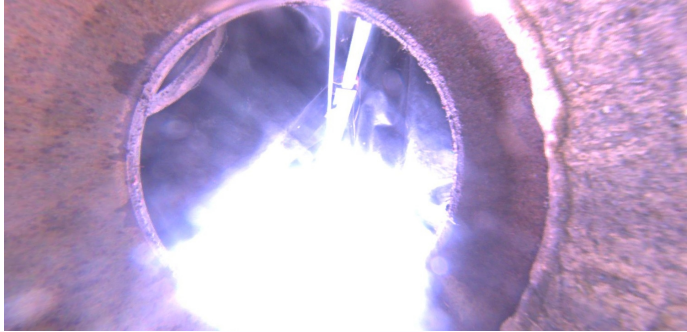
Code:	<b>MGO</b>
Description:	<b>General Observation</b>
Distance (ft):	<b>1.1</b>
Structural Grade:	<b>0</b>
O&M Grade:	<b>0</b>
Clock Start/From:	
Clock To:	
1st Value:	
2nd Value:	
Value Percent:	
Step:	<b>NO</b>
Remarks:	<b>UNDERSIDE OF FRAME</b>

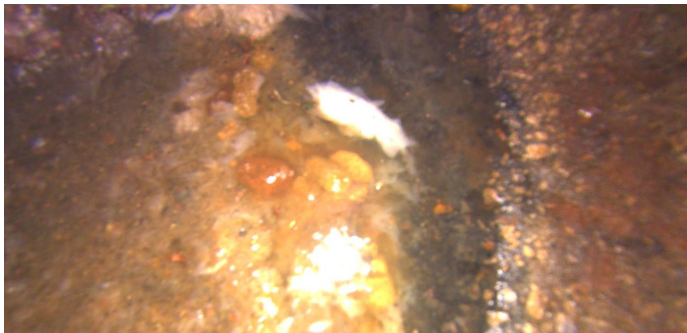
Code:	<b>MGO</b>
Description:	<b>General Observation</b>
Distance (ft):	<b>5.3</b>
Structural Grade:	<b>0</b>
O&M Grade:	<b>0</b>
Clock Start/From:	
Clock To:	
1st Value:	
2nd Value:	
Value Percent:	
Step:	<b>NO</b>
Remarks:	<b>END SURVEY</b>
