# Manhole Inspection Report

Date:	05/15/2018	Weather:		Coding:	RZMACP
MH#:	M-904-037	Owner:	NA	Len. Surveyed:	6.6
P.O.#:		Surveyor:	Jen Costello	Rim to Invert:	7.0
Customer:		Cert. #:	U-907-5518	Wall Material:	Concrete (reinforced)

Street:	Brandt Pl. 83' South of Division St.	Project:	Hobart, IN
City:	Hobart, IN	GPS Northing:	2910896.629
Location:		GPS Easting:	2910896.629
Drain Area:	Northeast	GPS Accuracy:	Sub-Meter
Cover Shape:	Circular	Evidence of Surcharge:	No
Cover Size:	22.5	Potential for Runoff:	None
Comments:

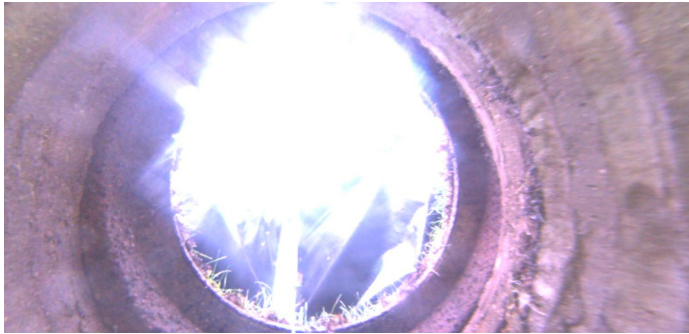
Code: **MGO**  
Description: **General Observation**

Distance (ft): **2.0**  
Structural Grade: **0**  
O&M Grade: **0**  
Clock Start/From:  
Clock To:  
1st Value:  
2nd Value:  
Value Percent:  
Step: **NO**  
Remarks: **UNDERSIDE OF FRAME**

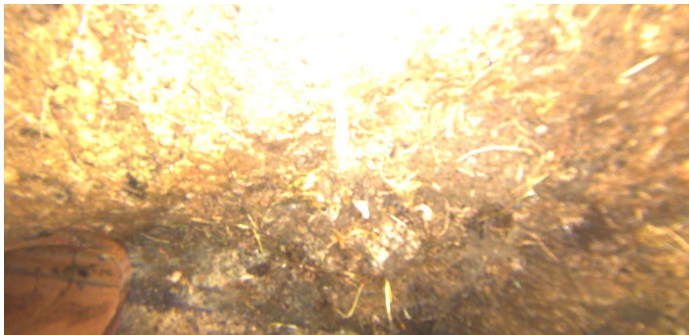
Code: **MGO**  
Description: **General Observation**

Distance (ft): **6.6**  
Structural Grade: **0**  
O&M Grade: **0**  
Clock Start/From:  
Clock To:  
1st Value:  
2nd Value:  
Value Percent:  
Step: **NO**  
Remarks: **END SURVEY**
