# Manhole Inspection Report

Date:	05/15/2018	Weather:		Coding:	RZMACP
MH#:	M-904-039	Owner:	NA	Len. Surveyed:	7.6
P.O.#:		Surveyor:	Jen Costello	Rim to Invert:	8.3
Customer:		Cert. #:	U-907-5518	Wall Material:	Concrete (reinforced)

Street:	Intersection of Hickey Pl. and Brand	Project:	Hobart, IN
City:	Hobart, IN	GPS Northing:	2910905.049
Location:		GPS Easting:	2910905.049
Drain Area:	Northeast	GPS Accuracy:	Sub-Meter
Cover Shape:	Circular	Evidence of Surcharge:	No
Cover Size:	22.5	Potential for Runoff:	None
Comments:

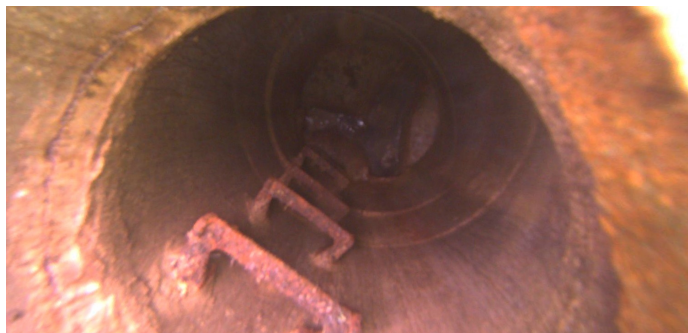
Code: **MGP**  
Description: **General Photo**

Distance (ft): **.0**  
Structural Grade: **0**  
O&M Grade: **0**  
Clock Start/From:  
Clock To:  
1st Value:  
2nd Value:  
Value Percent:  
Step: **NO**  
Remarks: **ACCESS MH**

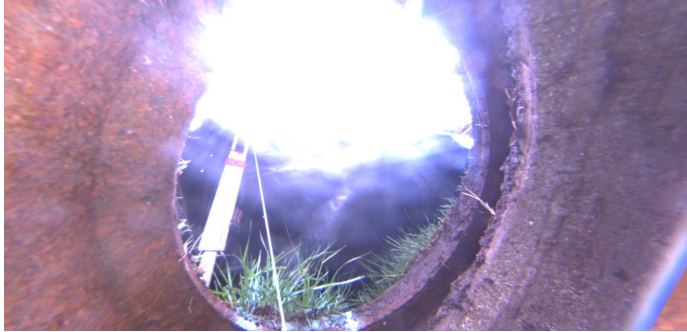
Code:	<b>MGO</b>
Description:	<b>General Observation</b>
Distance (ft):	<b>.9</b>
Structural Grade:	<b>0</b>
O&M Grade:	<b>0</b>
Clock Start/From:	
Clock To:	
1st Value:	
2nd Value:	
Value Percent:	
Step:	<b>NO</b>
Remarks:	<b>UNDERSIDE OF FRAME</b>

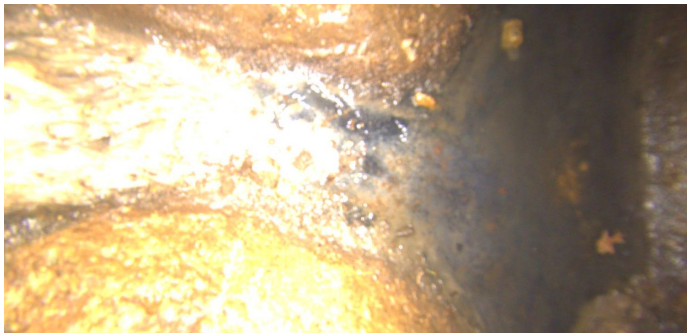
Code:	<b>MGO</b>
Description:	<b>General Observation</b>
Distance (ft):	<b>7.6</b>
Structural Grade:	<b>0</b>
O&M Grade:	<b>0</b>
Clock Start/From:	
Clock To:	
1st Value:	
2nd Value:	
Value Percent:	
Step:	<b>NO</b>
Remarks:	<b>END SURVEY</b>
