# Manhole Inspection Report

Date:	05/15/2018	Weather:		Coding:	RZMACP
MH#:	M-904-044	Owner:	NA	Len. Surveyed:	6.2
P.O.#:		Surveyor:	Jen Costello	Rim to Invert:	6.8
Customer:		Cert. #:	U-907-5518	Wall Material:	Concrete (reinforced)

Street:	Rush Ct. 152' South of Hickey St.	Project:	Hobart, IN
City:	Hobart, IN	GPS Northing:	2910586.84
Location:		GPS Easting:	2910586.84
Drain Area:	Northeast	GPS Accuracy:	Sub-Meter
Cover Shape:	Circular	Evidence of Surcharge:	No
Cover Size:	22.5	Potential for Runoff:	None
Comments:

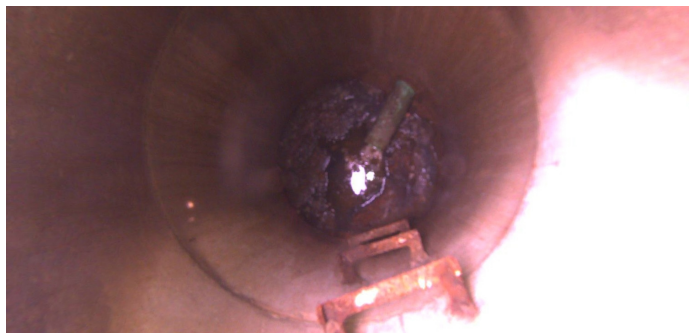
Code: **MGP**  
Description: **General Photo**

Distance (ft): **.0**  
Structural Grade: **0**  
O&M Grade: **0**  
Clock Start/From:  
Clock To:  
1st Value:  
2nd Value:  
Value Percent:  
Step: **NO**  
Remarks: **ACCESS MH**

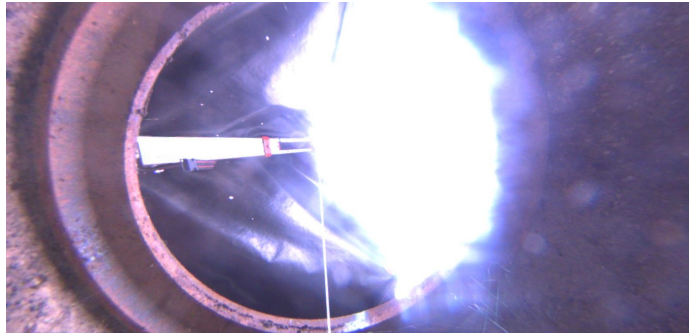
Code:	<b>MGO</b>
Description:	<b>General Observation</b>
Distance (ft):	<b>1.2</b>
Structural Grade:	<b>0</b>
O&M Grade:	<b>0</b>
Clock Start/From:	
Clock To:	
1st Value:	
2nd Value:	
Value Percent:	
Step:	<b>NO</b>
Remarks:	<b>UNDER SIDE OF FRAME</b>

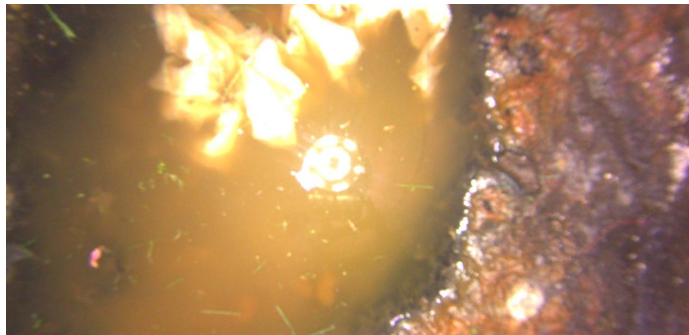
Code:	<b>MGO</b>
Description:	<b>General Observation</b>
Distance (ft):	<b>6.2</b>
Structural Grade:	<b>0</b>
O&M Grade:	<b>0</b>
Clock Start/From:	
Clock To:	
1st Value:	
2nd Value:	
Value Percent:	
Step:	<b>NO</b>
Remarks:	<b>END SURVEY</b>
