# Manhole Inspection Report

Date:	<b>05/15/2018</b>	Weather:		Coding:	<b>RZMACP</b>
MH#:	<b>M-904-045</b>	Owner:	<b>NA</b>	Len. Surveyed:	<b>9.9</b>
P.O.#:		Surveyor:	<b>Jen Costello</b>	Rim to Invert:	<b>10.7</b>
Customer:		Cert. #:	<b>U-907-5518</b>	Wall Material:	<b>Concrete (reinforced)</b>

Street:	<b>Rush Ct. 135' North of Hickey Pl.</b>	Project:	<b>Hobart, IN</b>
City:	<b>Hobart, IN</b>	GPS Northing:	<b>2910570.301</b>
Location:		GPS Easting:	<b>2910570.301</b>
Drain Area:	<b>Northeast</b>	GPS Accuracy:	<b>Sub-Meter</b>
Cover Shape:	<b>Circular</b>	Evidence of Surcharge:	<b>No</b>
Cover Size:	<b>22.5</b>	Potential for Runoff:	<b>None</b>
Comments:

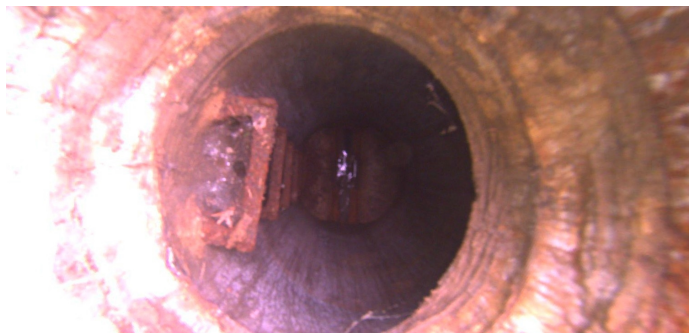
Code: **MGP**  
Description: **General Photo**

Distance (ft): **.0**  
Structural Grade: **0**  
O&M Grade: **0**  
Clock Start/From:  
Clock To:  
1st Value:  
2nd Value:  
Value Percent:  
Step: **NO**  
Remarks: **ACCESS MH**

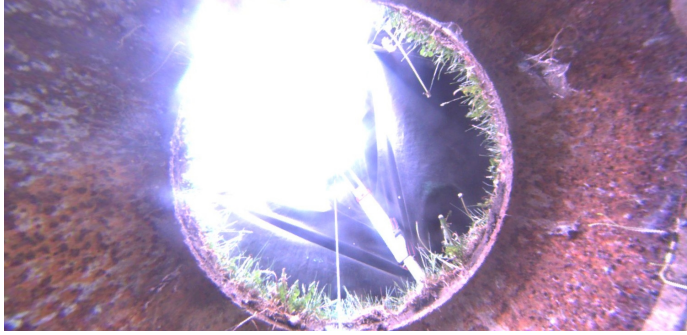
Code:	<b>MGO</b>
Description:	<b>General Observation</b>
Distance (ft):	<b>1.2</b>
Structural Grade:	<b>0</b>
O&M Grade:	<b>0</b>
Clock Start/From:	
Clock To:	
1st Value:	
2nd Value:	
Value Percent:	
Step:	<b>NO</b>
Remarks:	<b>UNDERSIDE OF FRAME</b>
