# Manhole Inspection Report

Date:	05/15/2018	Weather:		Coding:	RZMACP
MH#:	M-904-048	Owner:	NA	Len. Surveyed:	8.4
P.O.#:		Surveyor:	Jen Costello	Rim to Invert:	8.8
Customer:		Cert. #:	U-907-5518	Wall Material:	Concrete (reinforced)

Street:	Rush St. 192' South of Hickey St.	Project:	Hobart, IN
City:	Hobart, IN	GPS Northing:	2910138.281
Location:		GPS Easting:	2910138.281
Drain Area:	Northeast	GPS Accuracy:	Sub-Meter
Cover Shape:	Circular	Evidence of Surcharge:	No
Cover Size:	22.5	Potential for Runoff:	None
Comments:

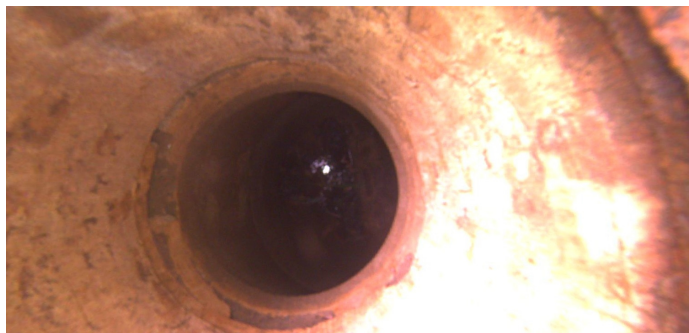
Code: **MGP**  
Description: **General Photo**

Distance (ft): **.0**  
Structural Grade: **0**  
O&M Grade: **0**  
Clock Start/From:  
Clock To:  
1st Value:  
2nd Value:  
Value Percent:  
Step: **NO**  
Remarks: **ACCESS MH**

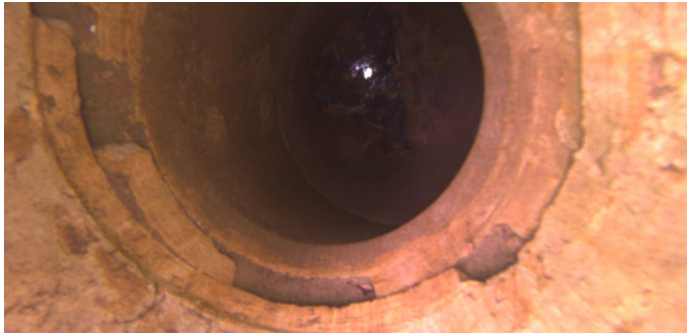
Code: **B**  
Description: **Broken**

Distance (ft): **.9**  
Structural Grade: **5**  
O&M Grade: **0**  
Clock Start/From: **4**  
Clock To: **10**  
1st Value:  
2nd Value:  
Value Percent:  
Step: **NO**  
Remarks:

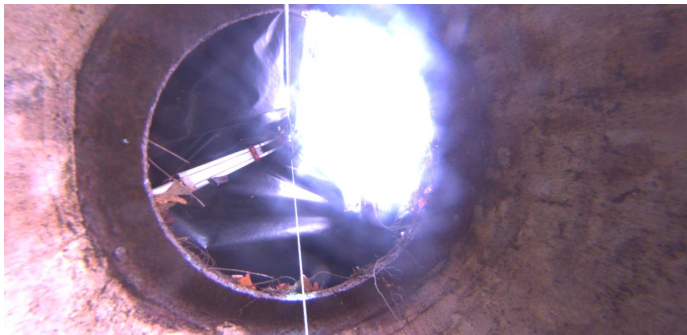
Code: **MGO**  
Description: **General Observation**

Distance (ft): **1.6**  
Structural Grade: **0**  
O&M Grade: **0**  
Clock Start/From:  
Clock To:  
1st Value:  
2nd Value:  
Value Percent:  
Step: **NO**  
Remarks: **UNDERSIDE OF FRAME**

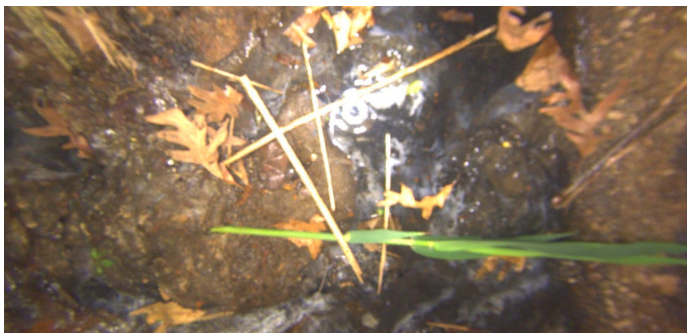
Code: **MGO**  
Description: **General Observation**

Distance (ft): **8.4**  
Structural Grade: **0**  
O&M Grade: **0**  
Clock Start/From:  
Clock To:  
1st Value:  
2nd Value:  
Value Percent:  
Step: **NO**  
Remarks: **END SURVEY**
