Manhole Inspection Report

| MH#: | M-904-059 | Owner: | NA | Len. Surveyed: | 7.3 |

| Street: | Division St. 332' East of Hwy 51. | Project: | Hobart, IN |

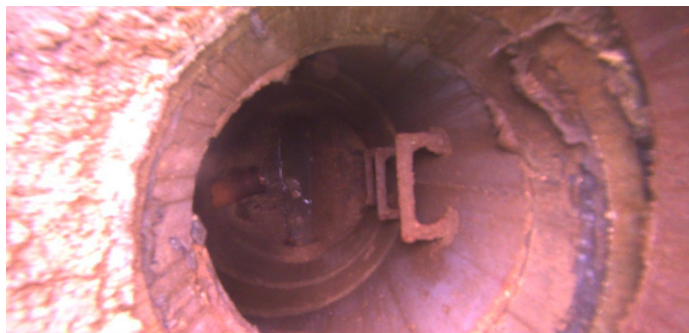
Code: **MGP**
Description: **General Photo**

Distance (ft): **.0**
Structural Grade: **0**
O&M Grade: **0**
Clock Start/From:
Clock To:
1st Value:
2nd Value:
Value Percent:
Step: **NO**
Remarks: **ACCESS MH**

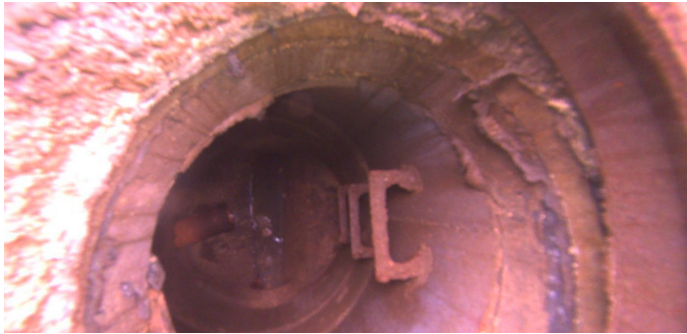
Code: **DAZ**
Description: **Deposits Attached Other**

Distance (ft): **.0**
Structural Grade: **0**
O&M Grade: **2**
Clock Start/From: **2**
Clock To: **3**
1st Value:
2nd Value:
Value Percent: **5.000**
Step: **NO**
Remarks:

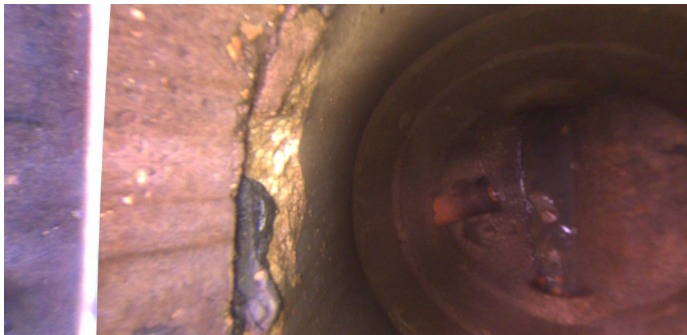
Code: **SSS**
Description: **Surface Spalling**

Distance (ft): **1.4**
Structural Grade: **2**
O&M Grade: **0**
Clock Start/From: **9**
Clock To:
1st Value:
2nd Value:
Value Percent:
Step: **NO**
Remarks:

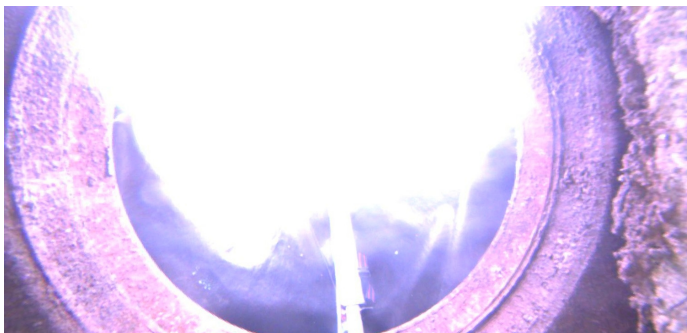
Code: **MGO**
Description: **General Observation**

Distance (ft): **1.4**
Structural Grade: **0**
O&M Grade: **0**
Clock Start/From:
Clock To:
1st Value:
2nd Value:
Value Percent:
Step: **NO**
Remarks: **UNDERSIDE OF FRAME**

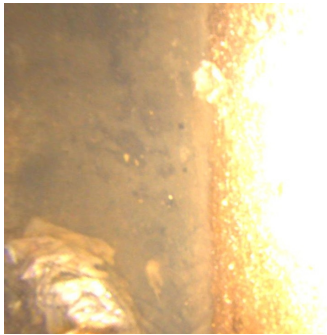
| Description: | General Observation |
| Remarks: | END SURVEY |
