Manhole Inspection Report

Date:	05/15/2018	Weather:		Coding:	RZMACP
MH#:	M-904-060	Owner:	NA	Len. Surveyed:	6.4
P.O.#:		Surveyor:	Jen Costello	Rim to Invert:	6.7
Customer:		Cert. #:	U-907-5518	Wall Material:	Concrete (reinforced)

Street:	Division St. 138' West of Rush Ct.	Project:	Hobart, IN
City:	Hobart, IN	GPS Northing:	2910405.879
Location:		GPS Easting:	2910405.879
Drain Area:	Northeast	GPS Accuracy:	Sub-Meter
Cover Shape:	Circular	Evidence of Surcharge:	No
Cover Size:	22.5	Potential for Runoff:	None
Comments:

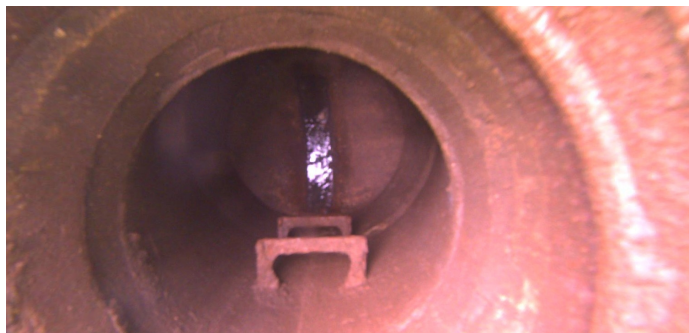
Code: **MGP**
 Description: **General Photo**

Distance (ft): **.0**
 Structural Grade: **0**
 O&M Grade: **0**
 Clock Start/From:
 Clock To:
 1st Value:
 2nd Value:
 Value Percent:
 Step: **NO**
 Remarks: **ACCESS MH**

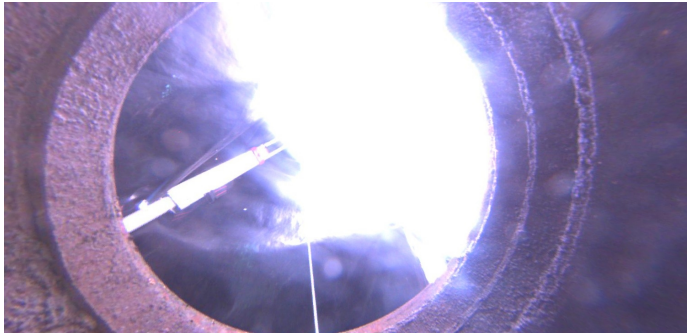
Code:	MGO
Description:	General Observation
Distance (ft):	1.1
Structural Grade:	0
O&M Grade:	0
Clock Start/From:	
Clock To:	
1st Value:	
2nd Value:	
Value Percent:	
Step:	NO
Remarks:	UNDERSIDE OF FRAME

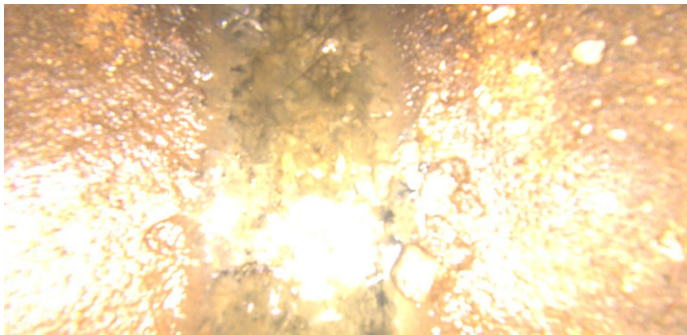
Code:	MGO
Description:	General Observation
Distance (ft):	6.4
Structural Grade:	0
O&M Grade:	0
Clock Start/From:	
Clock To:	
1st Value:	
2nd Value:	
Value Percent:	
Step:	NO
Remarks:	END SURVEY
