Manhole Inspection Report

Date:	05/08/2018	Weather:		Coding:	RZMACP
MH#:	M-904-064	Owner:	NA	Len. Surveyed:	6.5
P.O.#:		Surveyor:	Jen Costello	Rim to Invert:	6.9
Customer:		Cert. #:	U-907-5518	Wall Material:	Concrete (reinforced)

Street:	Intersection of Home Ave. and Pem	Project:	Hobart, IN
City:	Hobart, IN	GPS Northing:	2912180.768
Location:		GPS Easting:	2912180.768
Drain Area:	Northeast	GPS Accuracy:	Sub-Meter
Cover Shape:	Circular	Evidence of Surcharge:	No
Cover Size:	22.5	Potential for Runoff:	None
Comments:

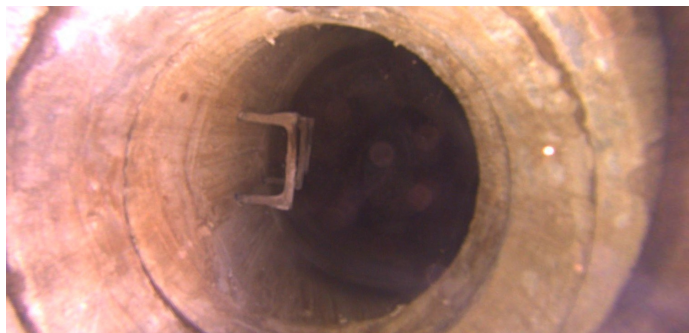
Code: **MGP**
Description: **General Photo**

Distance (ft): **.0**
Structural Grade: **0**
O&M Grade: **0**
Clock Start/From:
Clock To:
1st Value:
2nd Value:
Value Percent:
Step: **NO**
Remarks: **access mh**

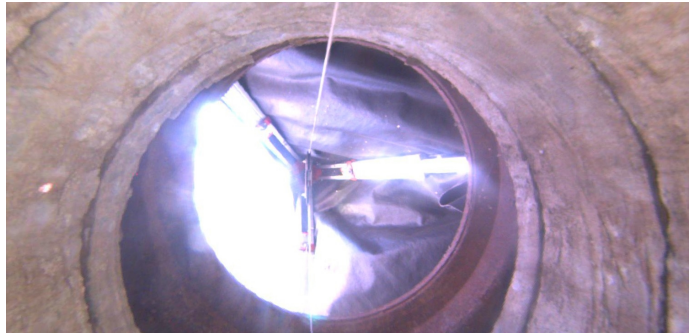
Code: **MGO**
Description: **General Observation**

Distance (ft): **2.3**
Structural Grade: **0**
O&M Grade: **0**
Clock Start/From:
Clock To:
1st Value:
2nd Value:
Value Percent:
Step: **NO**
Remarks: **underside of frame**

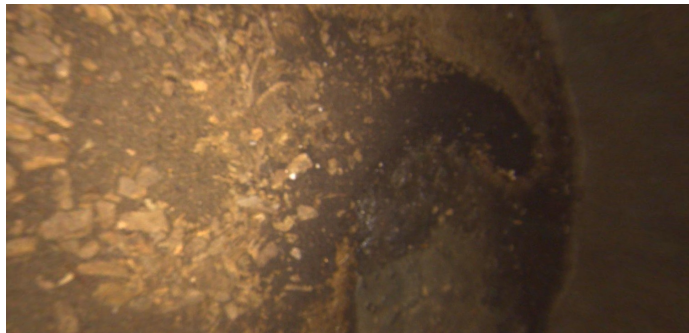
Code: **DSF**
Description: **Deposits Settled Fine**

Distance (ft): **5.3**
Structural Grade: **0**
O&M Grade: **2**
Clock Start/From: **12**
Clock To: **12**
1st Value:
2nd Value:
Value Percent: **10.000**
Step: **NO**
Remarks:

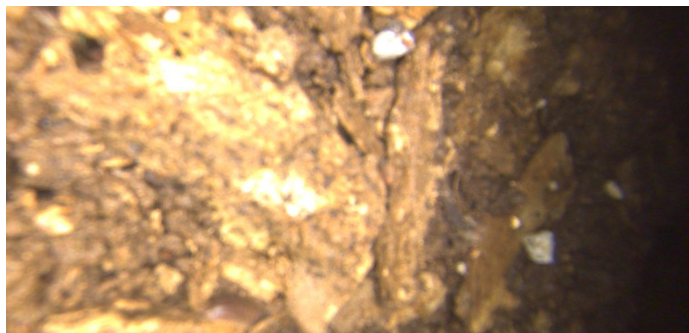
Code: **MGO**
Description: **General Observation**

Distance (ft): **6.5**
Structural Grade: **0**
O&M Grade: **0**
Clock Start/From:
Clock To:
1st Value:
2nd Value:
Value Percent:
Step: **NO**
Remarks: **end survey**
