Manhole Inspection Report

Date:	05/11/2018	Weather:		Coding:	RZMACP
MH#:	M-904-068	Owner:	NA	Len. Surveyed:	8.0
P.O.#:		Surveyor:	Jen Costello	Rim to Invert:	8.7
Customer:		Cert. #:	U-907-5518	Wall Material:	Concrete (reinforced)

Street:	Pembroke Dr. West. 309' South of P	Project:	Hobart, IN
City:	Hobart, IN	GPS Northing:	2911861.283
Location:		GPS Easting:	2911861.283
Drain Area:	Northeast	GPS Accuracy:	Sub-Meter
Cover Shape:	Circular	Evidence of Surcharge:	No
Cover Size:	22.5	Potential for Runoff:	None
Comments:

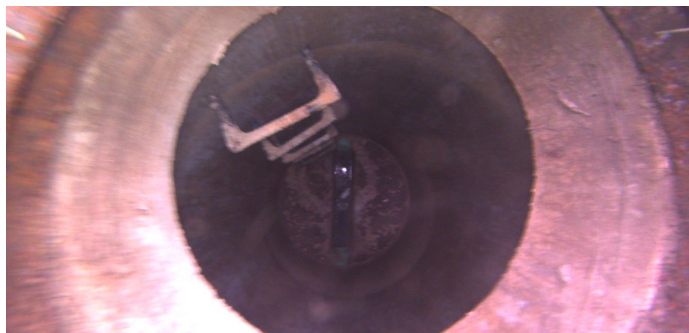
Code: **MGO**
Description: **General Observation**

Distance (ft): **.0**
Structural Grade: **0**
O&M Grade: **0**
Clock Start/From:
Clock To:
1st Value:
2nd Value:
Value Percent:
Step: **NO**
Remarks: **ACCESS MH**

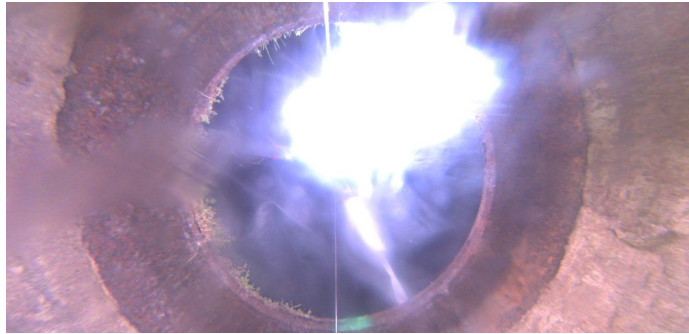
Code:	MGO
Description:	General Observation
Distance (ft):	1.9
Structural Grade:	0
O&M Grade:	0
Clock Start/From:	
Clock To:	
1st Value:	
2nd Value:	
Value Percent:	
Step:	NO
Remarks:	UNDERSIDE OF FRAME

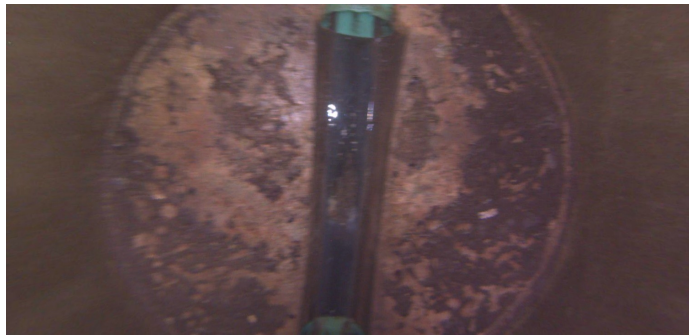
Code:	DSF
Description:	Deposits Settled Fine
Distance (ft):	6.5
Structural Grade:	0
O&M Grade:	2
Clock Start/From:	12
Clock To:	12
1st Value:	
2nd Value:	
Value Percent:	5.000
Step:	NO
Remarks:

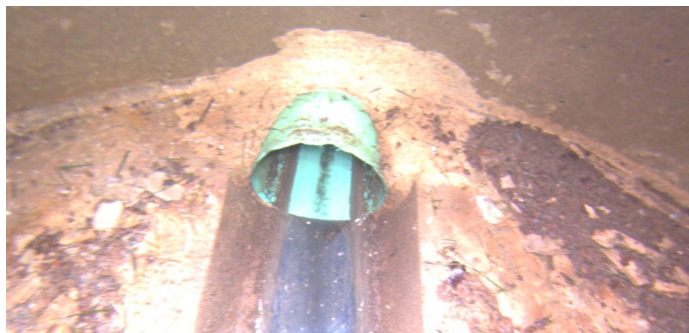
Code:	MGO
Description:	General Observation
Distance (ft):	7.9
Structural Grade:	0
O&M Grade:	0
Clock Start/From:	
Clock To:	
1st Value:	
2nd Value:	
Value Percent:	
Step:	NO
Remarks:	END SURVEY
