Manhole Inspection Report

| MH#: | M-904-071 | Owner: | NA | Len. Surveyed: | 9.8 |

| Street: | North of Pembroke Dr. N. and 624' | Project: | Hobart, IN |

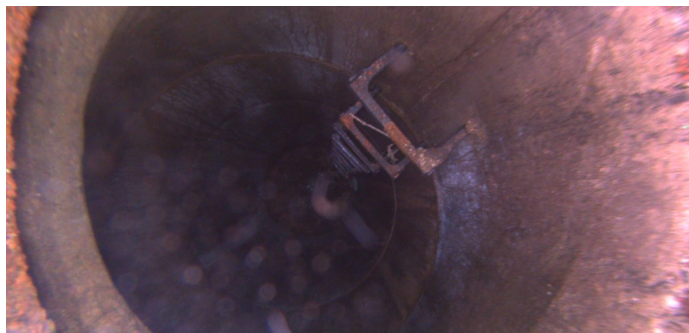
Code: **MGO**
Description: **General Observation**

Distance (ft): **.0**
Structural Grade: **0**
O&M Grade: **0**
Clock Start/From:
Clock To:
1st Value:
2nd Value:
Value Percent:
Step: **NO**
Remarks: **ACCESS MH**

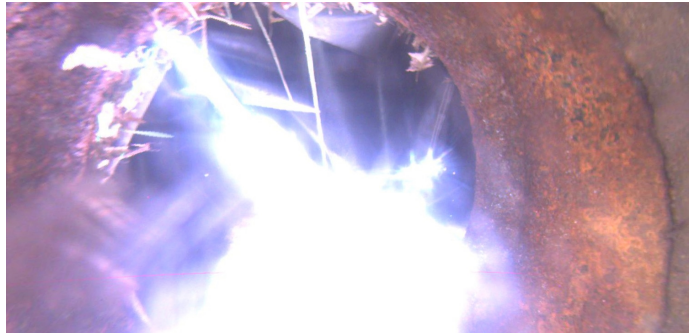
| Code: | MGO |
| Description: | General Observation |
| Distance (ft): | 1.7 |
| Remarks: | UNDERSIDE OF FRAME |

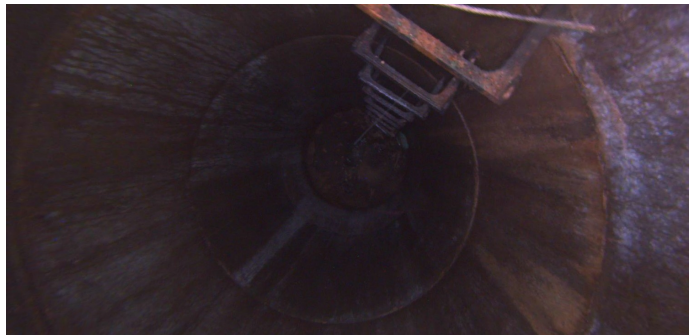
| Code: | IS |
| Description: | Infil Stain |
| Distance (ft): | 1.7 |
| Clock Start/From: | 12 |

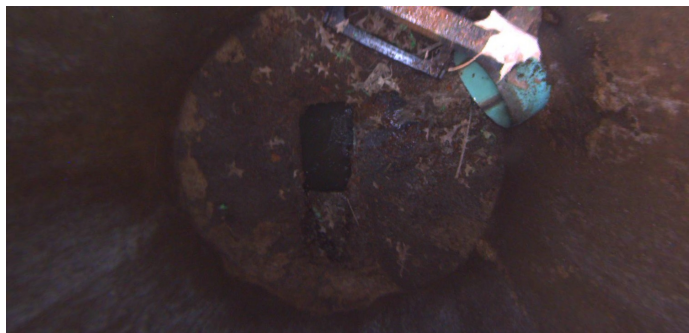
| Code: | DSF |
| Description: | Deposits Settled Fine |
| Distance (ft): | 9.8 |
| O&M Grade: | 2 |
| Value Percent: | 5.000 |

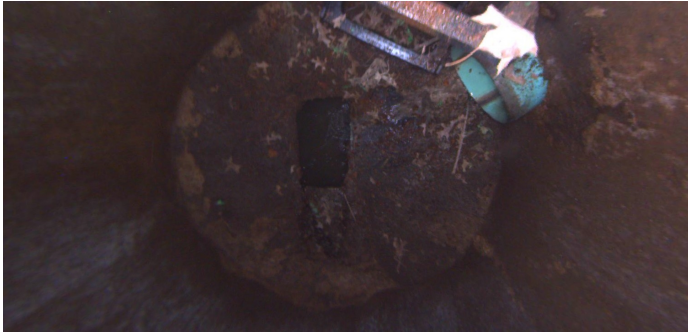
| Code: | MGO |
| Description: | General Observation |
| Distance (ft): | 9.8 |
| Remarks: | END SURVEY |
