Manhole Inspection Report

Date:	05/10/2018	Weather:		Coding:	RZMACP
MH#:	M-905-005	Owner:	NA	Len. Surveyed:	10.4
P.O.#:		Surveyor:	Jen Costello	Rim to Invert:	10.8
Customer:		Cert. #:	U-907-5518	Wall Material:	Concrete (reinforced)

Street:	Intersection of Sullivan St. and State	Project:	Hobart, IN
City:	Hobart, IN	GPS Northing:	2911750.552
Location:		GPS Easting:	2911750.552
Drain Area:	Southeast	GPS Accuracy:	Sub-Meter
Cover Shape:	Circular	Evidence of Surcharge:	No
Cover Size:	22.5	Potential for Runoff:	None
Comments:

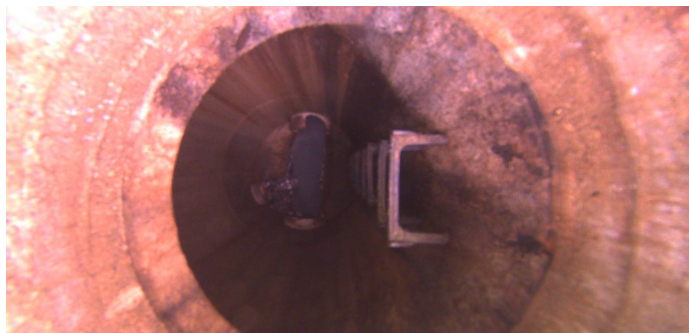
Code: **MGP**
Description: **General Photo**

Distance (ft): **.0**
Structural Grade: **0**
O&M Grade: **0**
Clock Start/From:
Clock To:
1st Value:
2nd Value:
Value Percent:
Step: **NO**
Remarks: **ACCESS MH**

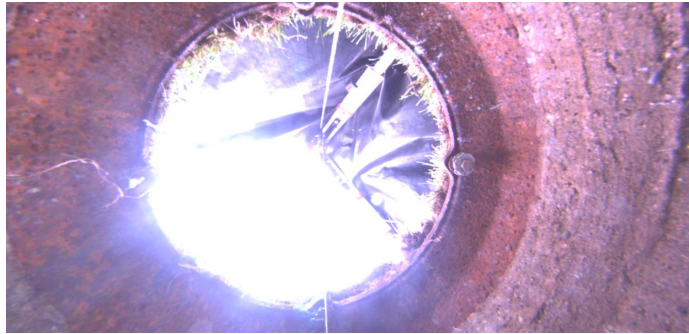
Code: **MGO**
Description: **General Observation**

Distance (ft): **1.7**
Structural Grade: **0**
O&M Grade: **0**
Clock Start/From:
Clock To:
1st Value:
2nd Value:
Value Percent:
Step: **NO**
Remarks: **UNDERSIDE OF FRAME**

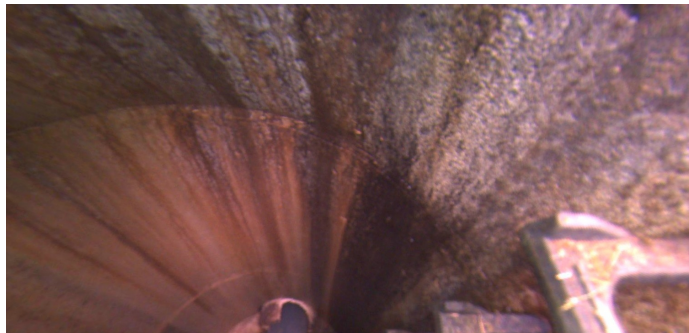
Code: **IS**
Description: **Infil Stain**

Distance (ft): **1.9**
Structural Grade: **0**
O&M Grade: **0**
Clock Start/From: **9**
Clock To: **3**
1st Value:
2nd Value:
Value Percent:
Step: **NO**
Remarks:

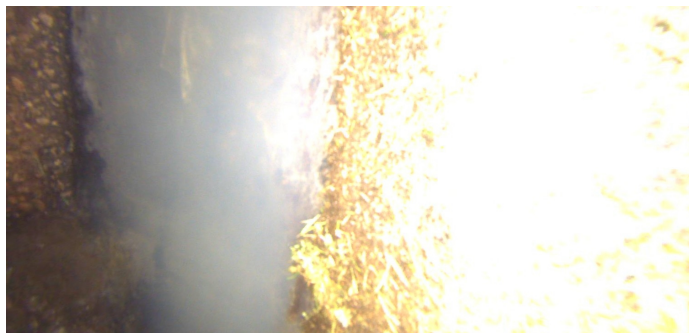
Code: **MGO**
Description: **General Observation**

Distance (ft): **10.4**
Structural Grade: **0**
O&M Grade: **0**
Clock Start/From:
Clock To:
1st Value:
2nd Value:
Value Percent:
Step: **NO**
Remarks: **END SURVEY**
