Manhole Inspection Report

Date:	05/10/2018	Weather:		Coding:	RZMACP
MH#:	M-905-008	Owner:	NA	Len. Surveyed:	6.5
P.O.#:		Surveyor:	Jen Costello	Rim to Invert:	7.0
Customer:		Cert. #:	U-907-5518	Wall Material:	Concrete (reinforced)

Street:	Sullivan St. 875' North of State Rd. 1	Project:	Hobart, IN
City:	Hobart, IN	GPS Northing:	2911724.056
Location:		GPS Easting:	2911724.056
Drain Area:	Southeast	GPS Accuracy:	Sub-Meter
Cover Shape:	Circular	Evidence of Surcharge:	No
Cover Size:	22.5	Potential for Runoff:	None
Comments:

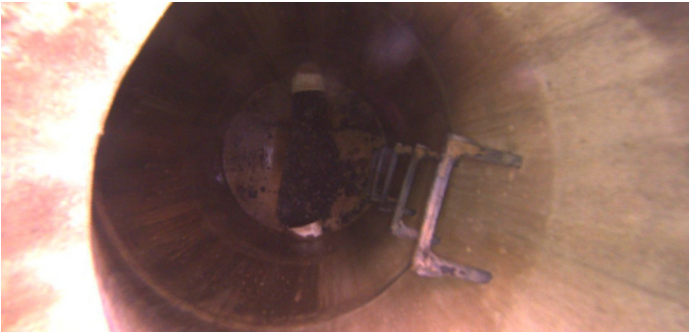
Code: **MGP**
Description: **General Photo**

Distance (ft): **.0**
Structural Grade: **0**
O&M Grade: **0**
Clock Start/From:
Clock To:
1st Value:
2nd Value:
Value Percent:
Step: **NO**
Remarks: **ACCESS MH**

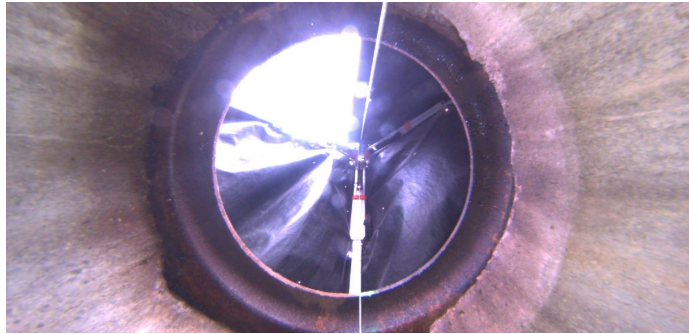
Code:	MGO
Description:	General Observation
Distance (ft):	1.7
Structural Grade:	0
O&M Grade:	0
Clock Start/From:	
Clock To:	
1st Value:	
2nd Value:	
Value Percent:	
Step:	NO
Remarks:	UNDERSIDE OF FRAME

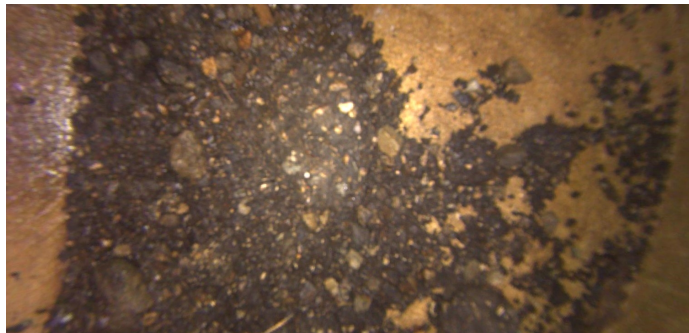
Code:	DSF
Description:	Deposits Settled Fine
Distance (ft):	6.0
Structural Grade:	0
O&M Grade:	5
Clock Start/From:	3
Clock To:	9
1st Value:	
2nd Value:	
Value Percent:	40.000
Step:	NO
Remarks:

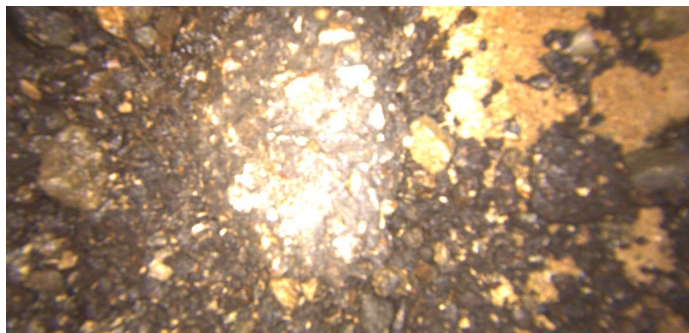
Code:	MGO
Description:	General Observation
Distance (ft):	6.5
Structural Grade:	0
O&M Grade:	0
Clock Start/From:	
Clock To:	
1st Value:	
2nd Value:	
Value Percent:	
Step:	NO
Remarks:	END SURVEY
