# Manhole Inspection Report

Date:	05/10/2018	Weather:		Coding:	RZMACP
MH#:	M-905-010	Owner:	NA	Len. Surveyed:	10.6
P.O.#:		Surveyor:	Jen Costello	Rim to Invert:	11.3
Customer:		Cert. #:	U-907-5518	Wall Material:	Concrete (reinforced)

Street:	State Rd. 130. 343' West of Sullivan	Project:	Hobart, IN
City:	Hobart, IN	GPS Northing:	2911403.963
Location:		GPS Easting:	2911403.963
Drain Area:	Southeast	GPS Accuracy:	Sub-Meter
Cover Shape:	Circular	Evidence of Surcharge:	No
Cover Size:	22.5	Potential for Runoff:	None
Comments:

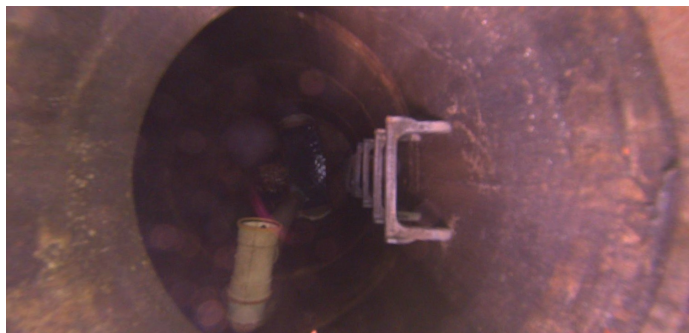
Code: **MGP**  
Description: **General Photo**

Distance (ft): **.0**  
Structural Grade: **0**  
O&M Grade: **0**  
Clock Start/From:  
Clock To:  
1st Value:  
2nd Value:  
Value Percent:  
Step: **NO**  
Remarks: **ACCESS MH**

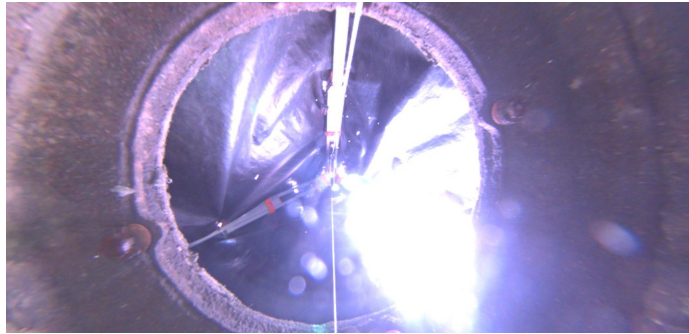
Code:	<b>MGO</b>
Description:	<b>General Observation</b>
Distance (ft):	<b>1.3</b>
Structural Grade:	<b>0</b>
O&M Grade:	<b>0</b>
Clock Start/From:	
Clock To:	
1st Value:	
2nd Value:	
Value Percent:	
Step:	<b>NO</b>
Remarks:	<b>UNDERSIDE OF FRAME</b>

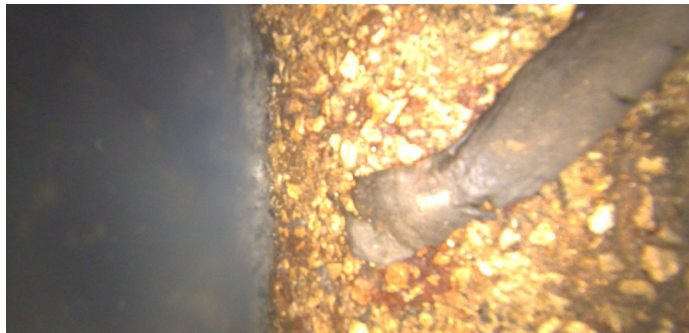
Code:	<b>SAP</b>
Description:	<b>Surface Aggregate Projecting</b>
Distance (ft):	<b>10.6</b>
Structural Grade:	<b>3</b>
O&M Grade:	<b>0</b>
Clock Start/From:	<b>12</b>
Clock To:	<b>12</b>
1st Value:	
2nd Value:	
Value Percent:	
Step:	<b>NO</b>
Remarks:

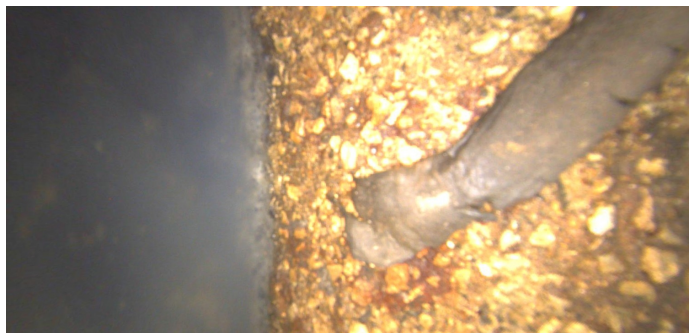
Code:	<b>MGO</b>
Description:	<b>General Observation</b>
Distance (ft):	<b>10.6</b>
Structural Grade:	<b>0</b>
O&M Grade:	<b>0</b>
Clock Start/From:	
Clock To:	
1st Value:	
2nd Value:	
Value Percent:	
Step:	<b>NO</b>
Remarks:	<b>END SURVEY</b>
