# Manhole Inspection Report

Date:	05/09/2018	Weather:		Coding:	RZMACP
MH#:	M-905-012	Owner:	NA	Len. Surveyed:	13.4
P.O.#:		Surveyor:	Jen Costello	Rim to Invert:	13.6
Customer:		Cert. #:	U-907-5518	Wall Material:	Concrete (reinforced)

Street:	State Rd. 130. 330' West of Shelby S	Project:	Hobart, IN
City:	Hobart, IN	GPS Northing:	2910770.221
Location:		GPS Easting:	2910770.221
Drain Area:	Southeast	GPS Accuracy:	Sub-Meter
Cover Shape:	Circular	Evidence of Surcharge:	No
Cover Size:	22.5	Potential for Runoff:	None
Comments:

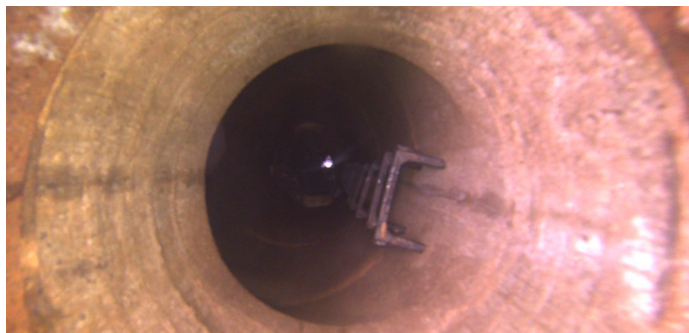
Code: **MGO**  
Description: **General Observation**

Distance (ft): **.0**  
Structural Grade: **0**  
O&M Grade: **0**  
Clock Start/From:  
Clock To:  
1st Value:  
2nd Value:  
Value Percent:  
Step: **NO**  
Remarks: **ACCESS MH**

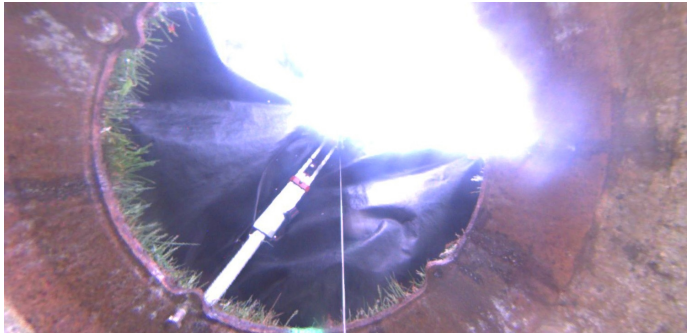
Code: **MGO**  
Description: **General Observation**

Distance (ft): **1.7**  
Structural Grade: **0**  
O&M Grade: **0**  
Clock Start/From:  
Clock To:  
1st Value:  
2nd Value:  
Value Percent:  
Step: **NO**  
Remarks: **UNDERSIDE OF FRAME**

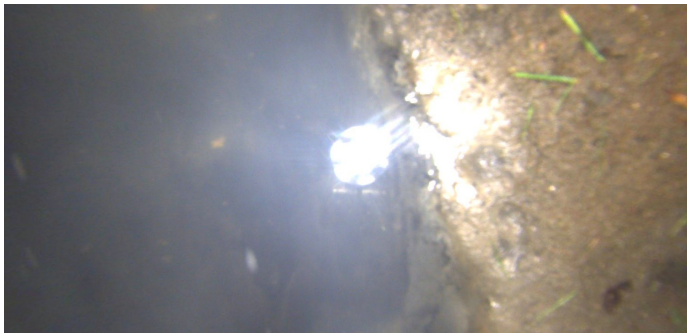
Code: **MGO**  
Description: **General Observation**

Distance (ft): **13.4**  
Structural Grade: **0**  
O&M Grade: **0**  
Clock Start/From:  
Clock To:  
1st Value:  
2nd Value:  
Value Percent:  
Step: **NO**  
Remarks: **END SURVEY**
