Manhole Inspection Report

Date:	05/09/2018	Weather:		Coding:	RZMACP
MH#:	M-905-016	Owner:	NA	Len. Surveyed:	14.3
P.O.#:		Surveyor:	Jen Costello	Rim to Invert:	14.6
Customer:		Cert. #:	U-907-5518	Wall Material:	Concrete (reinforced)

Street:	State Rd. 130. 245' East of Hobart R	Project:	Hobart, IN
City:	Hobart, IN	GPS Northing:	2910005.65
Location:		GPS Easting:	2910005.65
Drain Area:	Southeast	GPS Accuracy:	Sub-Meter
Cover Shape:	Circular	Evidence of Surcharge:	No
Cover Size:	22.5	Potential for Runoff:	None
Comments:

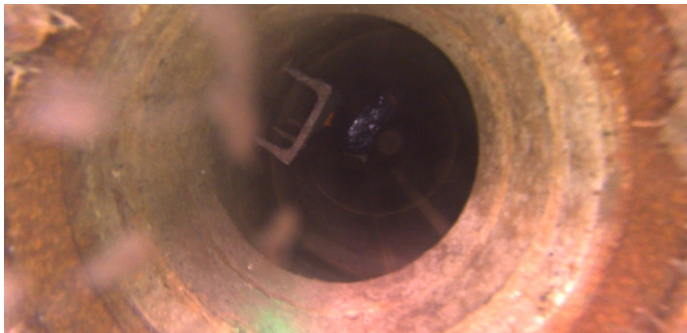
Code: **MGO**
Description: **General Observation**

Distance (ft): **.0**
Structural Grade: **0**
O&M Grade: **0**
Clock Start/From:
Clock To:
1st Value:
2nd Value:
Value Percent:
Step: **NO**
Remarks: **ACCESS MH**

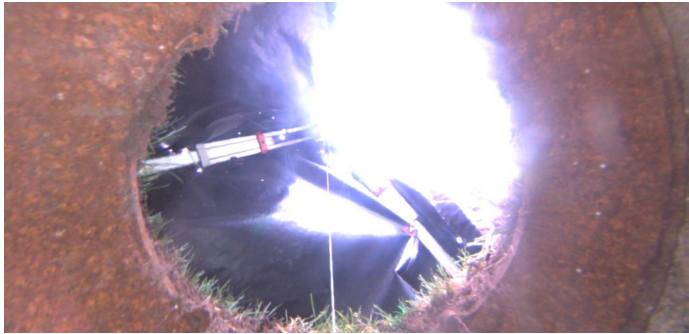
Code: **MGO**
Description: **General Observation**

Distance (ft): **1.9**
Structural Grade: **0**
O&M Grade: **0**
Clock Start/From:
Clock To:
1st Value:
2nd Value:
Value Percent:
Step: **NO**
Remarks: **UNDERSIDE OF FRAME**

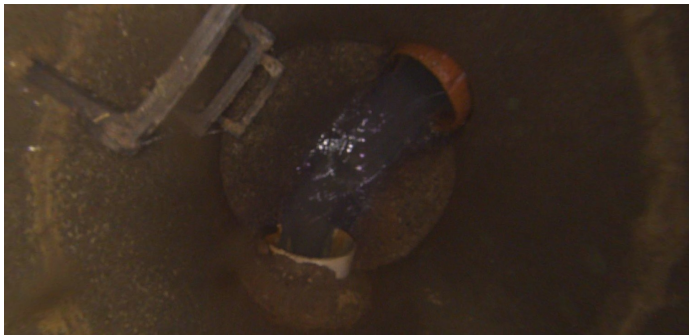
Code: **SAV**
Description: **Surface Aggregate Visible**

Distance (ft): **10.1**
Structural Grade: **3**
O&M Grade: **0**
Clock Start/From: **12**
Clock To: **12**
1st Value:
2nd Value:
Value Percent:
Step: **NO**
Remarks:

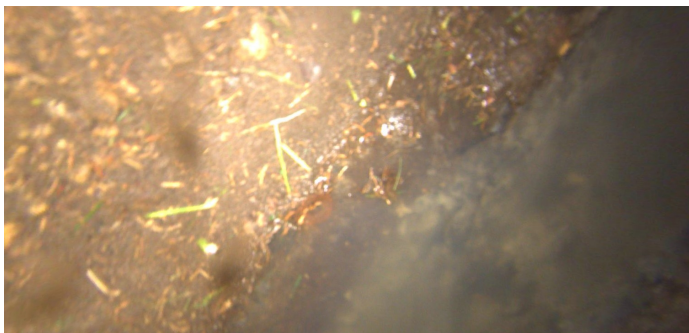
Code: **MGO**
Description: **General Observation**

Distance (ft): **14.3**
Structural Grade: **0**
O&M Grade: **0**
Clock Start/From:
Clock To:
1st Value:
2nd Value:
Value Percent:
Step: **NO**
Remarks: **END SURVEY**
