Manhole Inspection Report

Date:	05/07/2018	Weather:		Coding:	RZMACP
MH#:	M-905-018	Owner:	NA	Len. Surveyed:	2.0
P.O.#:		Surveyor:	Jen Costello	Rim to Invert:	2.2
Customer:		Cert. #:	U-907-5518	Wall Material:	Concrete (reinforced)

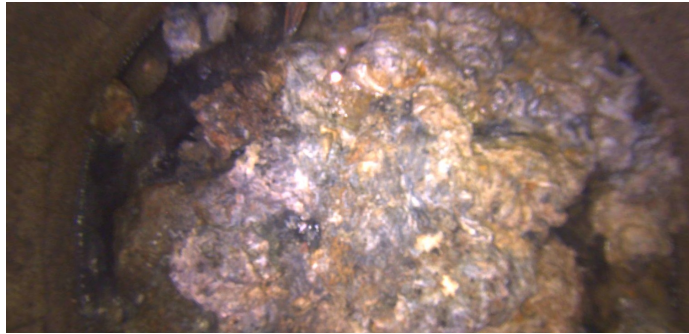
Code:	MGP
Description:	General Photo

Distance (ft):	.0
Structural Grade:	0
O&M Grade:	0
Clock Start/From:	
Clock To:	
1st Value:	
2nd Value:	
Value Percent:	
Step:	NO
Remarks:	AC

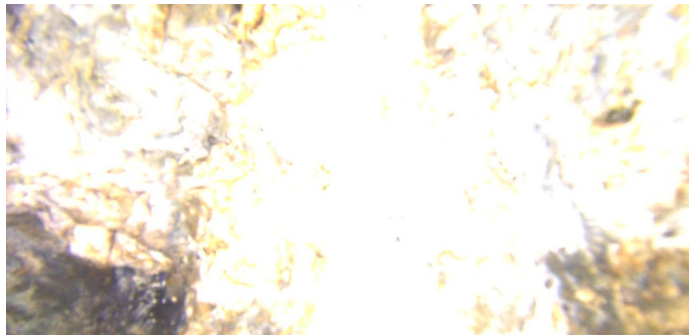
Code:	DSZ
Description:	Deposits Settled Other
Distance (ft):	.9
Structural Grade:	0
O&M Grade:	2
Clock Start/From:	12
Clock To:	12
1st Value:	
2nd Value:	
Value Percent:	10.000
Step:	NO
Remarks:	MISC
