# Manhole Inspection Report

Date:	05/07/2018	Weather:		Coding:	RZMACP
MH#:	M-905-020	Owner:	NA	Len. Surveyed:	1.7
P.O.#:		Surveyor:	Jen Costello	Rim to Invert:	2.3
Customer:		Cert. #:	U-907-5518	Wall Material:	Concrete (reinforced)

Street:	32' East of Hwy 130. 616' South of C	Project:	Hobart, IN
City:	Hobart, IN	GPS Northing:	2909795.393
Location:		GPS Easting:	2909795.393
Drain Area:	South	GPS Accuracy:	Sub-Meter
Cover Shape:	Circular	Evidence of Surcharge:	No
Cover Size:	22.5	Potential for Runoff:	None
Comments:

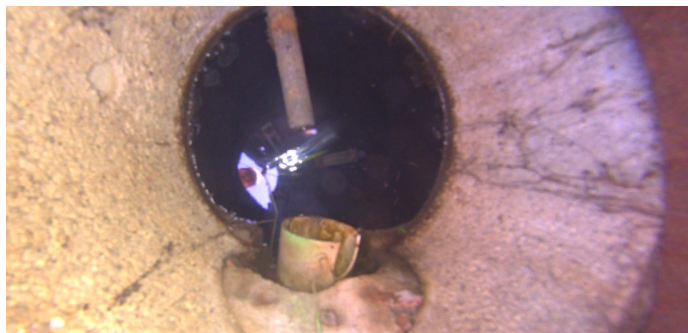
Code: **MGP**  
Description: **General Photo**

Distance (ft): **.0**  
Structural Grade: **0**  
O&M Grade: **0**  
Clock Start/From:  
Clock To:  
1st Value:  
2nd Value:  
Value Percent:  
Step: **NO**  
Remarks: **ACCESS MH**

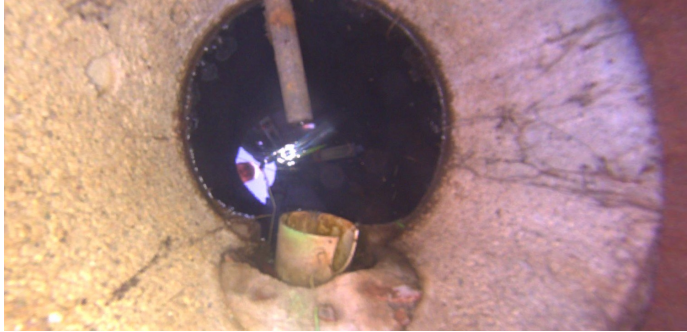
Code: **RFJ**  
Description: **Roots Fine Joint**

Distance (ft): **.0**  
Structural Grade: **0**  
O&M Grade: **1**  
Clock Start/From: **12**  
Clock To: **12**  
1st Value:  
2nd Value:  
Value Percent:  
Step: **NO**  
Remarks:

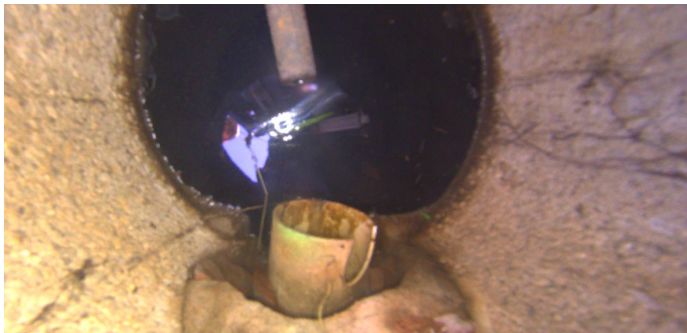
Code: **SAV**  
Description: **Surface Aggregate Visible**

Distance (ft): **.7**  
Structural Grade: **3**  
O&M Grade: **0**  
Clock Start/From: **12**  
Clock To: **12**  
1st Value:  
2nd Value:  
Value Percent:  
Step: **NO**  
Remarks:

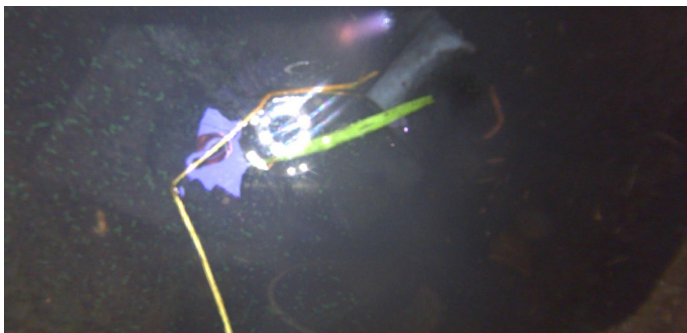
Code: **MGO**  
Description: **General Observation**

Distance (ft): **1.7**  
Structural Grade: **0**  
O&M Grade: **0**  
Clock Start/From:  
Clock To:  
1st Value:  
2nd Value:  
Value Percent:  
Step: **NO**  
Remarks: **END SURVEY**
