Manhole Inspection Report

Date:	05/09/2018	Weather:		Coding:	RZMACP
MH#:	M-905-021	Owner:	NA	Len. Surveyed:	3.2
P.O.#:		Surveyor:	Jen Costello	Rim to Invert:	3.5
Customer:		Cert. #:	U-907-5518	Wall Material:	Concrete (reinforced)

Street:	195' East of Hwy 130. 1010' South o	Project:	Hobart, IN
City:	Hobart, IN	GPS Northing:	2910043.662
Location:		GPS Easting:	2910043.662
Drain Area:	Southeast	GPS Accuracy:	Sub-Meter
Cover Shape:	Circular	Evidence of Surcharge:	No
Cover Size:	22.5	Potential for Runoff:	None
Comments:

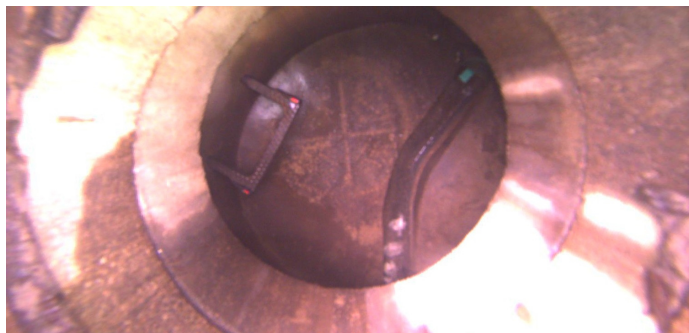
Code: **MGP**
 Description: **General Photo**

Distance (ft): **.0**
 Structural Grade: **0**
 O&M Grade: **0**
 Clock Start/From:
 Clock To:
 1st Value:
 2nd Value:
 Value Percent:
 Step: **NO**
 Remarks: **ACCESS MH**

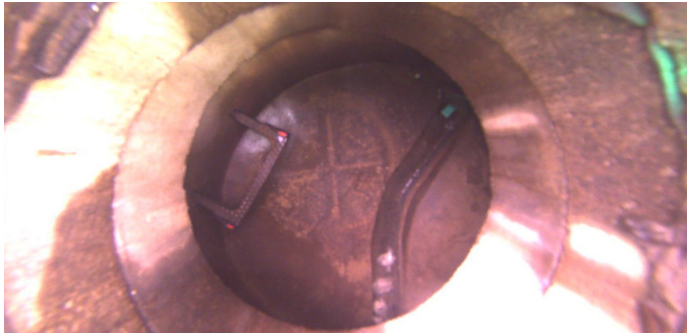
Code: **SRI**
Description: **Surface Roughness Increased**

Distance (ft): **.0**
Structural Grade: **1**
O&M Grade: **0**
Clock Start/From: **12**
Clock To: **12**
1st Value:
2nd Value:
Value Percent:
Step: **NO**
Remarks:

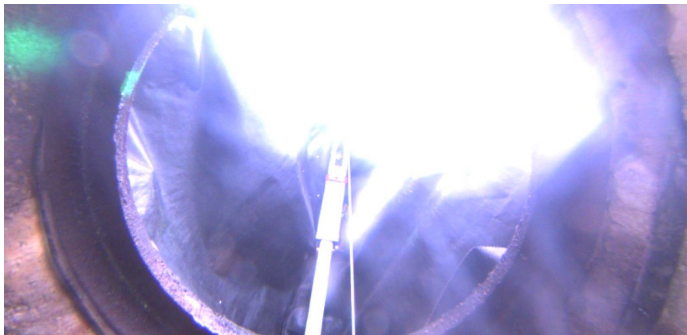
Code: **MGO**
Description: **General Observation**

Distance (ft): **1.5**
Structural Grade: **0**
O&M Grade: **0**
Clock Start/From:
Clock To:
1st Value:
2nd Value:
Value Percent:
Step: **NO**
Remarks: **UNDERSIDE OF FRAME**

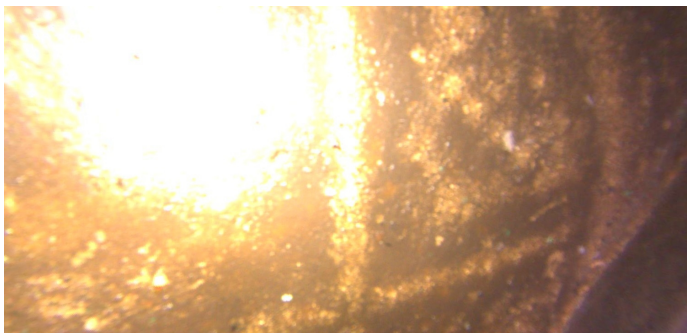
Code: **MGO**
Description: **General Observation**

Distance (ft): **3.2**
Structural Grade: **0**
O&M Grade: **0**
Clock Start/From:
Clock To:
1st Value:
2nd Value:
Value Percent:
Step: **NO**
Remarks: **END SURVEY**
