Manhole Inspection Report

Date:	05/09/2018	Weather:		Coding:	RZMACP
MH#:	M-905-022	Owner:	NA	Len. Surveyed:	3.8
P.O.#:		Surveyor:	Jen Costello	Rim to Invert:	3.9
Customer:		Cert. #:	U-907-5518	Wall Material:	Concrete (reinforced)

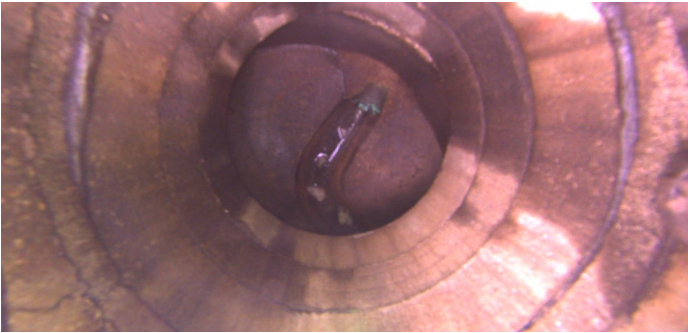
MGP

General Photo

ACCESS MH

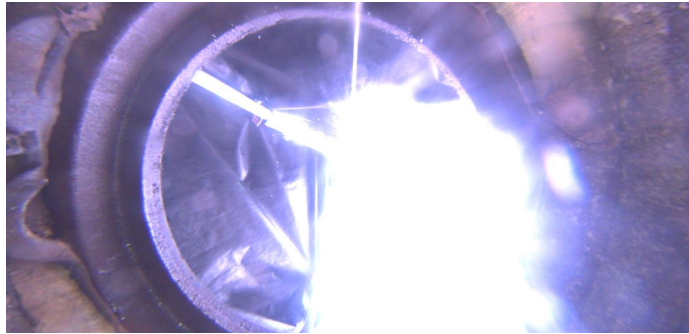
Code: **MGO**
Description: **General Observation**

Distance (ft): **1.5**
Structural Grade: **0**
O&M Grade: **0**
Clock Start/From:
Clock To:
1st Value:
2nd Value:
Value Percent:
Step: **NO**
Remarks: **UNDERSIDE OF FRAME**

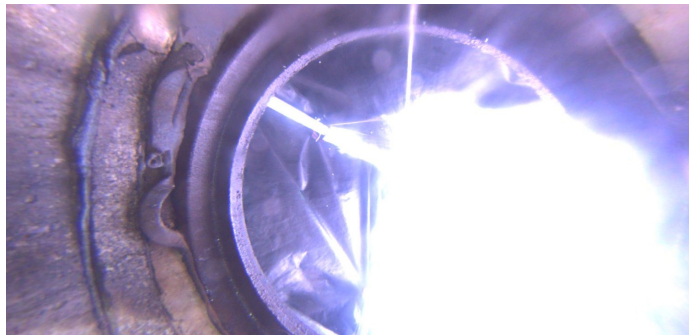
Code: **ISSRB**
Description: **Intruding Sealing Ring Broken**

Distance (ft): **1.5**
Structural Grade: **0**
O&M Grade: **2**
Clock Start/From: **2**
Clock To: **3**
1st Value:
2nd Value:
Value Percent: **5.000**
Step: **NO**
Remarks:

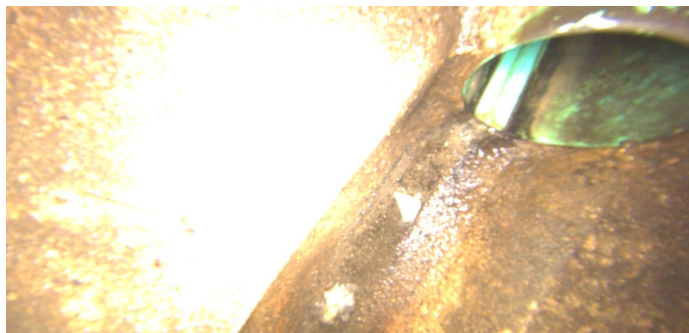
Code: **MGO**
Description: **General Observation**

Distance (ft): **3.8**
Structural Grade: **0**
O&M Grade: **0**
Clock Start/From:
Clock To:
1st Value:
2nd Value:
Value Percent:
Step: **NO**
Remarks: **END SURVEY**
