Manhole Inspection Report

Date:	05/09/2018	Weather:		Coding:	RZMACP
MH#:	M-905-023	Owner:	NA	Len. Surveyed:	2.8
P.O.#:		Surveyor:	Jen Costello	Rim to Invert:	2.7
Customer:		Cert. #:	U-907-5518	Wall Material:	Concrete (reinforced)

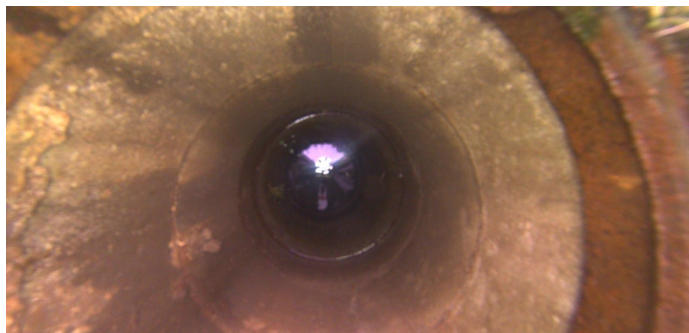
Code: **MGP**
 Description: **General Photo**

Distance (ft): **.0**
 Structural Grade: **0**
 O&M Grade: **0**
 Clock Start/From:
 Clock To:
 1st Value:
 2nd Value:
 Value Percent:
 Step: **NO**
 Remarks: **ACCESS MH**

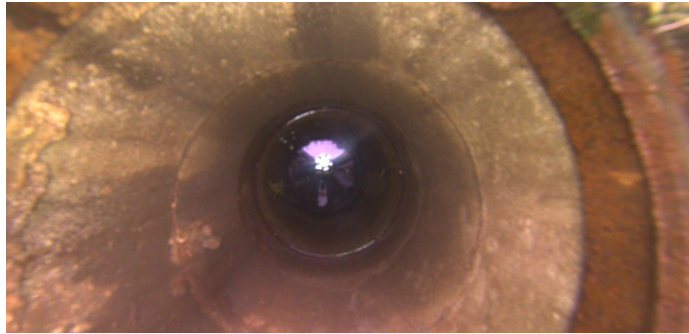
Code:	SAV
Description:	Surface Aggregate Visible
Distance (ft):	.0
Structural Grade:	3
O&M Grade:	0
Clock Start/From:	12
Clock To:	12
1st Value:	
2nd Value:	
Value Percent:	
Step:	NO
Remarks:

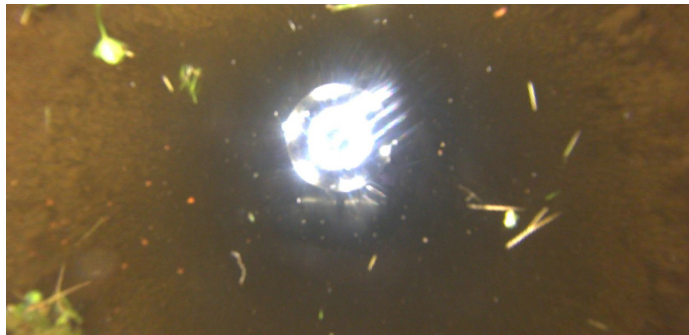
Code:	MSA
Description:	Abandoned Survey
Distance (ft):	2.8
Structural Grade:	0
O&M Grade:	0
Clock Start/From:	
Clock To:	
1st Value:	
2nd Value:	
Value Percent:	
Step:	NO
Remarks:	BENCH IS SUBMERGED
