# Manhole Inspection Report

Date:	09/27/2022	Weather:		Coding:	RZMACP
MH#:	M-905-024	Owner:	NA	Len. Surveyed:	3.7
P.O.#:		Surveyor:	Todd Machine	Rim to Invert:	4.2
Customer:		Cert. #:	P0038859-082022	Wall Material:	Concrete (cast in place)

Street:	208' North of Hwy 130. 193' West o	Project:	Hobart, IN
City:	Hobart, IN	GPS Northing:	2288632.98
Location:	Local Rural Streets	GPS Easting:	2910890.71
Drain Area:	Southeast	GPS Accuracy:	Sub-Meter
Cover Shape:	Circular	Evidence of Surcharge:	Yes
Cover Size:	24.0	Potential for Runoff:	None
Comments:

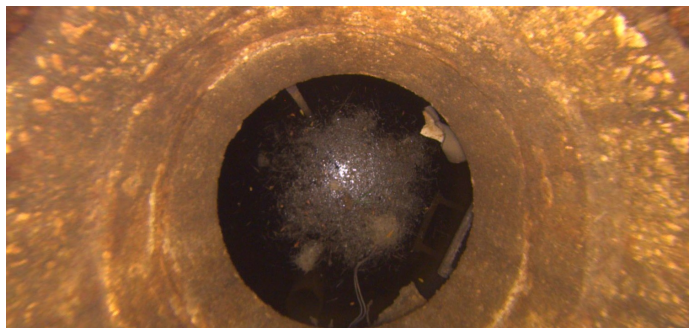
Code: **MGO**  
Description: **General Observation**

Distance (ft): **.0**  
Structural Grade: **0**  
O&M Grade: **0**  
Clock Start/From:  
Clock To:  
1st Value:  
2nd Value:  
Value Percent:  
Step: **NO**  
Remarks: **access mh**

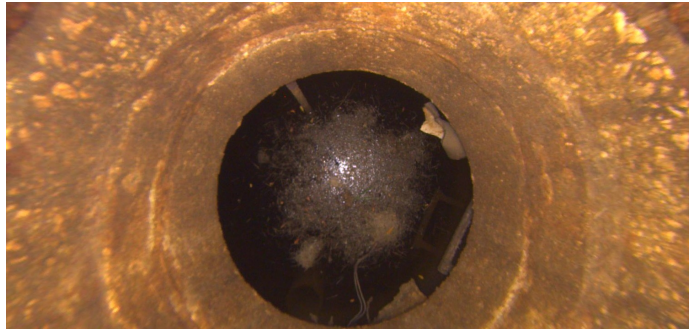
Code: **SAV**  
Description: **Surface Aggregate Visible**

Distance (ft): **.0**  
Structural Grade: **3**  
O&M Grade: **0**  
Clock Start/From: **12**  
Clock To: **12**  
1st Value:  
2nd Value:  
Value Percent:  
Step: **NO**  
Remarks:

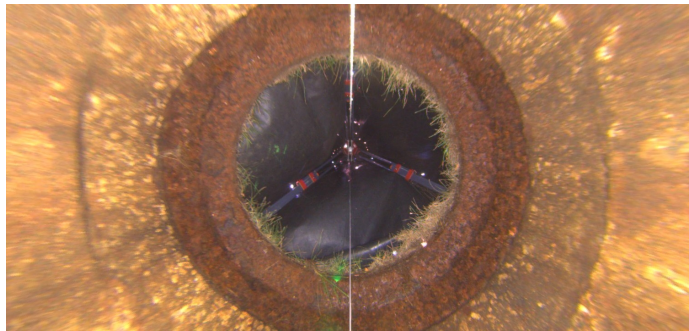
Code: **MGO**  
Description: **General Observation**

Distance (ft): **1.7**  
Structural Grade: **0**  
O&M Grade: **0**  
Clock Start/From:  
Clock To:  
1st Value:  
2nd Value:  
Value Percent:  
Step: **NO**  
Remarks: **Underside Of Frame**

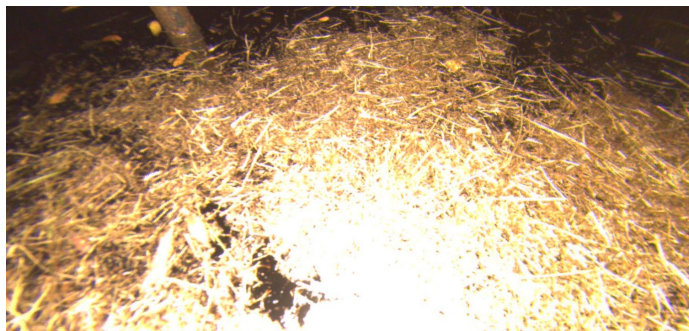
Code: **SAV**  
Description: **Surface Aggregate Visible**

Distance (ft): **3.7**  
Structural Grade: **3**  
O&M Grade: **0**  
Clock Start/From: **12**  
Clock To: **12**  
1st Value:  
2nd Value:  
Value Percent:  
Step: **NO**  
Remarks:

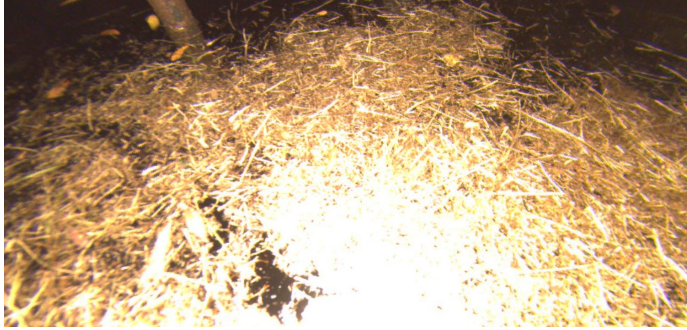
Code:	<b>MSA</b>
Description:	<b>Abandoned Survey</b>
Distance (ft):	<b>3.7</b>
Structural Grade:	<b>0</b>
O&M Grade:	<b>0</b>
Clock Start/From:	
Clock To:	
1st Value:	
2nd Value:	
Value Percent:	
Step:	<b>NO</b>
Remarks:	<b>Surcharged</b>
