Manhole Inspection Report

Date:	05/08/2018	Weather:		Coding:	RZMACP
MH#:	M-905-026	Owner:	NA	Len. Surveyed:	2.5
P.O.#:		Surveyor:	Jen Costello	Rim to Invert:	2.7
Customer:		Cert. #:	U-907-5518	Wall Material:	Concrete (reinforced)

Street:	386' West of Shelby St. 711' North of	Project:	Hobart, IN
City:	Hobart, IN	GPS Northing:	2910696.187
Location:		GPS Easting:	2910696.187
Drain Area:	Southeast	GPS Accuracy:	Sub-Meter
Cover Shape:	Circular	Evidence of Surcharge:	No
Cover Size:	22.5	Potential for Runoff:	None
Comments:

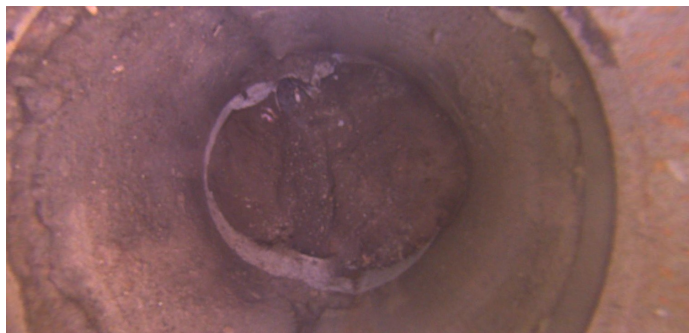
Code: **MGP**
Description: **General Photo**

Distance (ft): **.0**
Structural Grade: **0**
O&M Grade: **0**
Clock Start/From:
Clock To:
1st Value:
2nd Value:
Value Percent:
Step: **NO**
Remarks: **ACCESS MH**

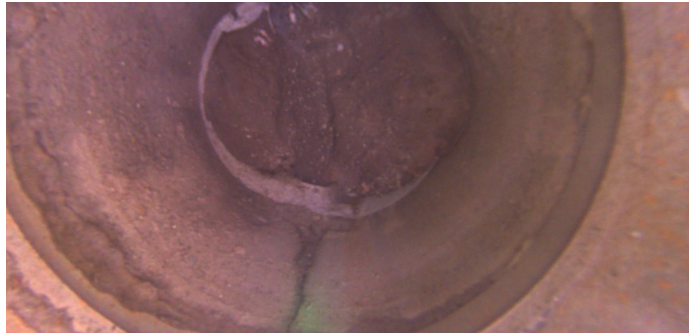
Code: **FL**
Description: **Fracture Longitudinal**

Distance (ft): **.0**
Structural Grade: **3**
O&M Grade: **0**
Clock Start/From: **6**
Clock To:
1st Value:
2nd Value:
Value Percent:
Step: **NO**
Remarks:

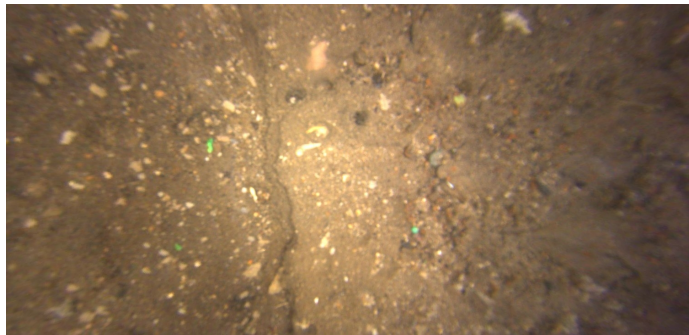
Code: **DSF**
Description: **Deposits Settled Fine**

Distance (ft): **2.2**
Structural Grade: **0**
O&M Grade: **5**
Clock Start/From: **3**
Clock To: **9**
1st Value:
2nd Value:
Value Percent: **40.000**
Step: **NO**
Remarks:

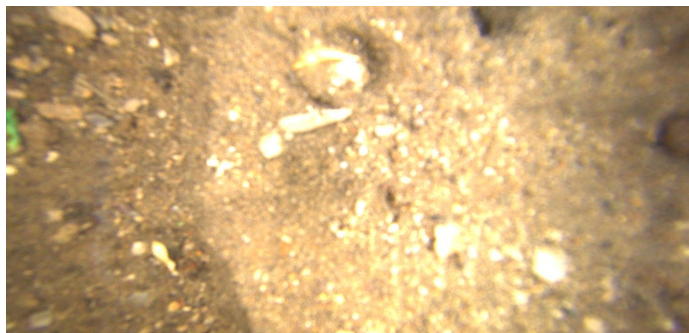
Code: **MGO**
Description: **General Observation**

Distance (ft): **2.5**
Structural Grade: **0**
O&M Grade: **0**
Clock Start/From:
Clock To:
1st Value:
2nd Value:
Value Percent:
Step: **NO**
Remarks: **END SURVEY**
