# Manhole Inspection Report

Date:	05/09/2018	Weather:		Coding:	RZMACP
MH#:	M-905-030	Owner:	NA	Len. Surveyed:	3.5
P.O.#:		Surveyor:	Jen Costello	Rim to Invert:	3.6
Customer:		Cert. #:	U-907-5518	Wall Material:	Concrete (reinforced)

Street:	132' West of Shelby St. 687' North of	Project:	Hobart, IN
City:	Hobart, IN	GPS Northing:	2910957.76
Location:		GPS Easting:	2910957.76
Drain Area:	Southeast	GPS Accuracy:	Sub-Meter
Cover Shape:	Circular	Evidence of Surcharge:	No
Cover Size:	22.5	Potential for Runoff:	None
Comments:

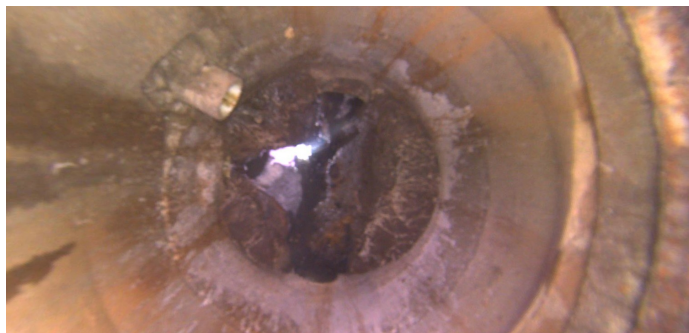
Code: **MGP**  
Description: **General Photo**

Distance (ft): **.0**  
Structural Grade: **0**  
O&M Grade: **0**  
Clock Start/From:  
Clock To:  
1st Value:  
2nd Value:  
Value Percent:  
Step: **NO**  
Remarks: **ACCESS MH**

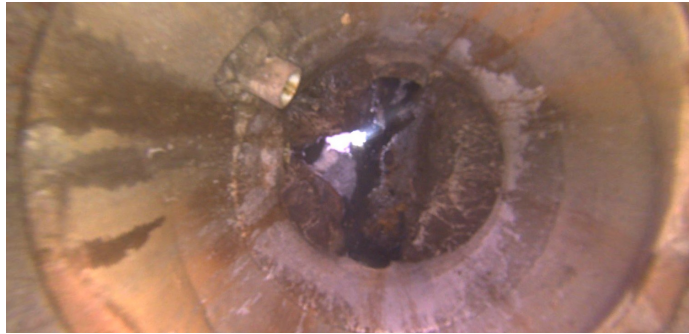
Code: **IW**  
Description: **Infil Weeper**

Distance (ft): **.0**  
Structural Grade: **0**  
O&M Grade: **2**  
Clock Start/From: **8**  
Clock To: **9**  
1st Value:  
2nd Value:  
Value Percent:  
Step: **NO**  
Remarks:

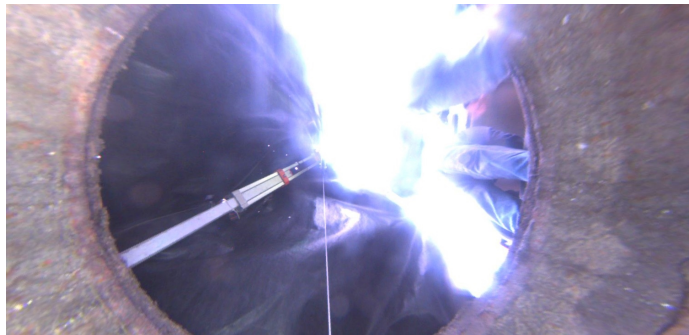
Code: **MGO**  
Description: **General Observation**

Distance (ft): **1.3**  
Structural Grade: **0**  
O&M Grade: **0**  
Clock Start/From:  
Clock To:  
1st Value:  
2nd Value:  
Value Percent:  
Step: **NO**  
Remarks: **UNDERSIDE OF FRAME**

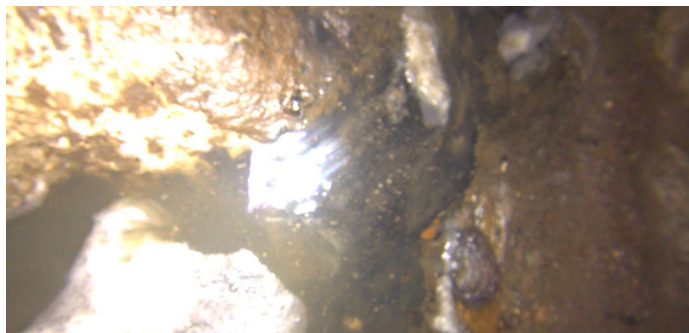
Code: **MGO**  
Description: **General Observation**

Distance (ft): **3.5**  
Structural Grade: **0**  
O&M Grade: **0**  
Clock Start/From:  
Clock To:  
1st Value:  
2nd Value:  
Value Percent:  
Step: **NO**  
Remarks: **END SURVEY**
