Manhole Inspection Report

Date:	05/09/2018	Weather:		Coding:	RZMACP
MH#:	M-905-031	Owner:	NA	Len. Surveyed:	4.1
P.O.#:		Surveyor:	Jen Costello	Rim to Invert:	3.6
Customer:		Cert. #:	U-907-5518	Wall Material:	Concrete (reinforced)

Street:	On Shelby St. 748' North of Hwy 130	Project:	Hobart, IN
City:	Hobart, IN	GPS Northing:	41.53255463
Location:		GPS Easting:	-87.2355423
Drain Area:	Southeast	GPS Accuracy:	Nearest Meter
Cover Shape:	Circular	Evidence of Surcharge:	No
Cover Size:	22.5	Potential for Runoff:	None
Comments:

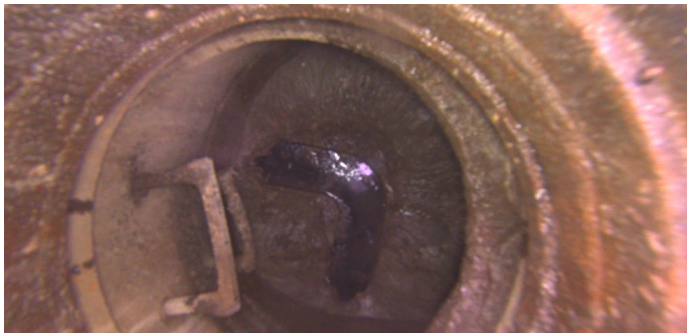
Code:	MGP
Description:	General Photo

Distance (ft):	.0
Structural Grade:	0
O&M Grade:	0
Clock Start/From:	
Clock To:	
1st Value:	
2nd Value:	
Value Percent:	
Step:	NO
Remarks:	AC

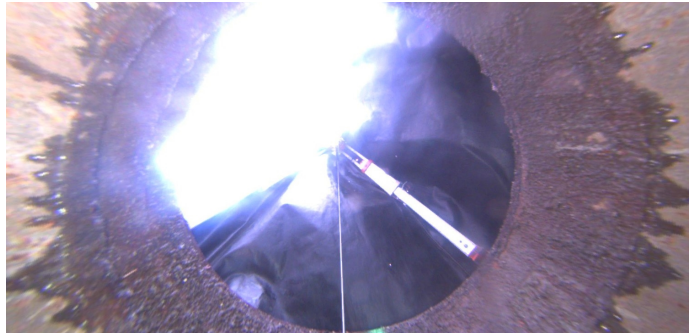
Code:	MGO
Description:	General Observation
Distance (ft):	1.7
Structural Grade:	0
O&M Grade:	0
Clock Start/From:	
Clock To:	
1st Value:	
2nd Value:	
Value Percent:	
Step:	NO
Remarks:	UNDERSIDE OF FRAME

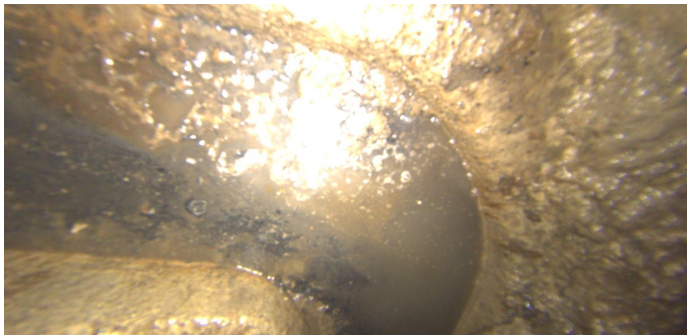
Code:	MGO
Description:	General Observation
Distance (ft):	4.1
Structural Grade:	0
O&M Grade:	0
Clock Start/From:	
Clock To:	
1st Value:	
2nd Value:	
Value Percent:	
Step:	NO
Remarks:	END SURVEY
