Manhole Inspection Report

Date:	05/09/2018	Weather:		Coding:	RZMACP
MH#:	M-905-033	Owner:	NA	Len. Surveyed:	4.2
P.O.#:		Surveyor:	Jen Costello	Rim to Invert:	4.6
Customer:		Cert. #:	U-907-5518	Wall Material:	Concrete (reinforced)

Street:	On Shelby St. 421' North of Hwy 130	Project:	Hobart, IN
City:	Hobart, IN	GPS Northing:	2911085.523
Location:		GPS Easting:	2911085.523
Drain Area:	Southeast	GPS Accuracy:	Sub-Meter
Cover Shape:	Circular	Evidence of Surcharge:	No
Cover Size:	22.5	Potential for Runoff:	None
Comments:

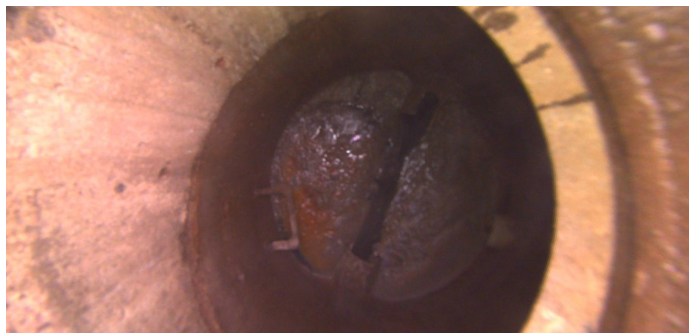
Code: **MGP**
Description: **General Photo**

Distance (ft): **.0**
Structural Grade: **0**
O&M Grade: **0**
Clock Start/From:
Clock To:
1st Value:
2nd Value:
Value Percent:
Step: **NO**
Remarks: **ACCESS MH**

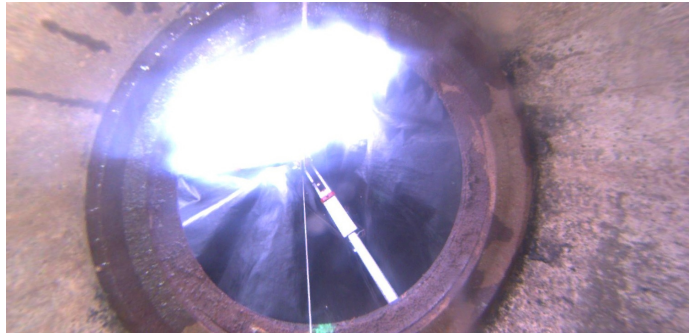
Code: **MGO**
Description: **General Observation**

Distance (ft): **1.9**
Structural Grade: **0**
O&M Grade: **0**
Clock Start/From:
Clock To:
1st Value:
2nd Value:
Value Percent:
Step: **NO**
Remarks: **UNDERSIDE OF FRAME**

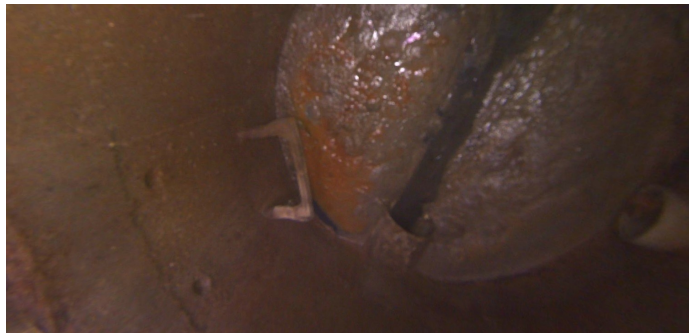
Code: **MGO**
Description: **General Observation**

Distance (ft): **1.9**
Structural Grade: **0**
O&M Grade: **0**
Clock Start/From:
Clock To:
1st Value:
2nd Value:
Value Percent:
Step: **NO**
Remarks: **MISSING STEP**

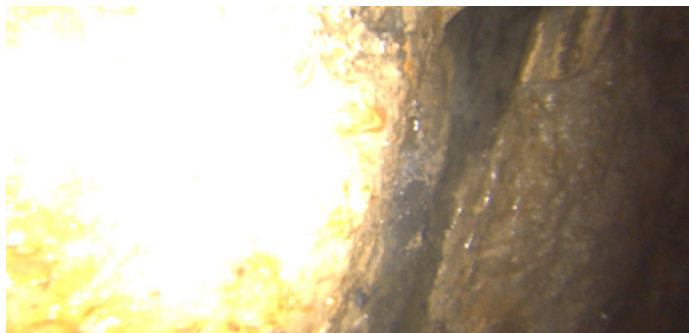
Code: **MGO**
Description: **General Observation**

Distance (ft): **4.2**
Structural Grade: **0**
O&M Grade: **0**
Clock Start/From:
Clock To:
1st Value:
2nd Value:
Value Percent:
Step: **NO**
Remarks: **END SURVEY**
