Manhole Inspection Report

Date:	05/09/2018	Weather:		Coding:	RZMACP
MH#:	M-905-034	Owner:	NA	Len. Surveyed:	2.1
P.O.#:		Surveyor:	Jen Costello	Rim to Invert:	2.4
Customer:		Cert. #:	U-907-5518	Wall Material:	Concrete (reinforced)

Street:	Hobart Rd. South of 5th St. at Alley.	Project:	Hobart, IN
City:	Hobart, IN	GPS Northing:	2910338.503
Location:		GPS Easting:	2910338.503
Drain Area:	Southeast	GPS Accuracy:	Sub-Meter
Cover Shape:	Circular	Evidence of Surcharge:	No
Cover Size:	22.5	Potential for Runoff:	None
Comments:

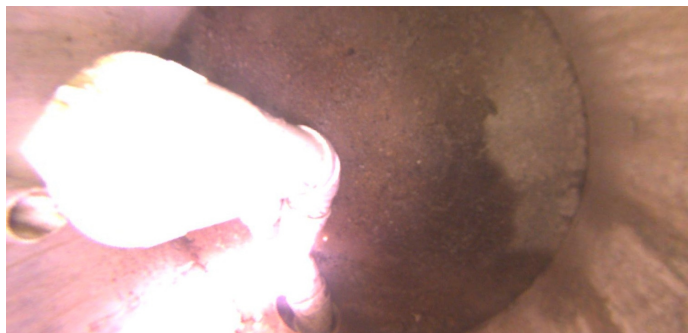
Code: **MGP**
Description: **General Photo**

Distance (ft): **.0**
Structural Grade: **0**
O&M Grade: **0**
Clock Start/From:
Clock To:
1st Value:
2nd Value:
Value Percent:
Step: **NO**
Remarks: **access mh**

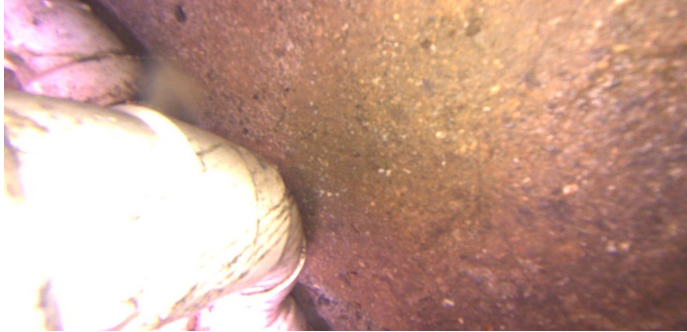
Code:	OBP
Description:	Obstacle External Pipe or Cable
Distance (ft):	1.8
Structural Grade:	0
O&M Grade:	2
Clock Start/From:	7
Clock To:	9
1st Value:	
2nd Value:	
Value Percent:	10.000
Step:	NO
Remarks:

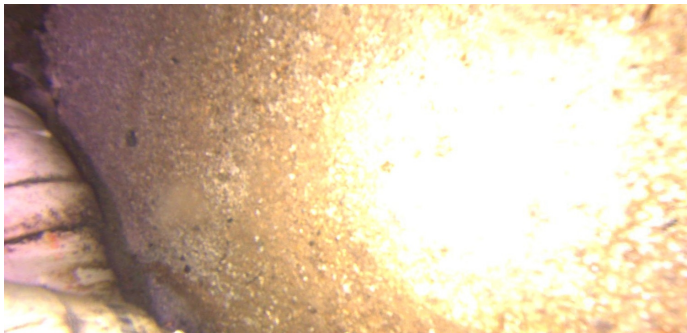
Code:	MGO
Description:	General Observation
Distance (ft):	2.1
Structural Grade:	0
O&M Grade:	0
Clock Start/From:	
Clock To:	
1st Value:	
2nd Value:	
Value Percent:	
Step:	NO
Remarks:	end survey
