# Manhole Inspection Report

Date:	05/09/2018	Weather:		Coding:	RZMACP
MH#:	M-905-035	Owner:	NA	Len. Surveyed:	4.0
P.O.#:		Surveyor:	Jen Costello	Rim to Invert:	4.1
Customer:		Cert. #:	U-907-5518	Wall Material:	Concrete (reinforced)

Street:	Hobart Rd. South of 5th St. at Alley.	Project:	Hobart, IN
City:	Hobart, IN	GPS Northing:	2910076.537
Location:		GPS Easting:	2910076.537
Drain Area:	Southeast	GPS Accuracy:	Sub-Meter
Cover Shape:	Circular	Evidence of Surcharge:	No
Cover Size:	22.5	Potential for Runoff:	None
Comments:

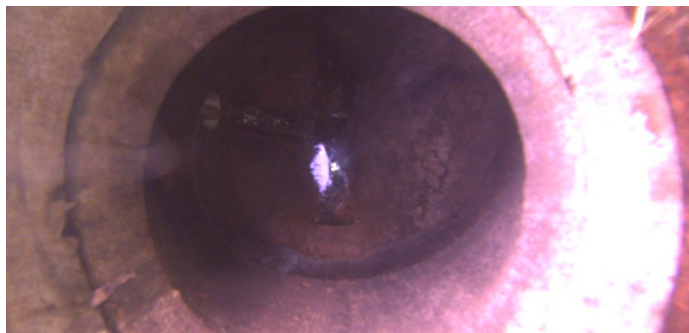
Code: **MGO**  
Description: **General Observation**

Distance (ft): **.0**  
Structural Grade: **0**  
O&M Grade: **0**  
Clock Start/From:  
Clock To:  
1st Value:  
2nd Value:  
Value Percent:  
Step: **NO**  
Remarks: **ACCESS MH**

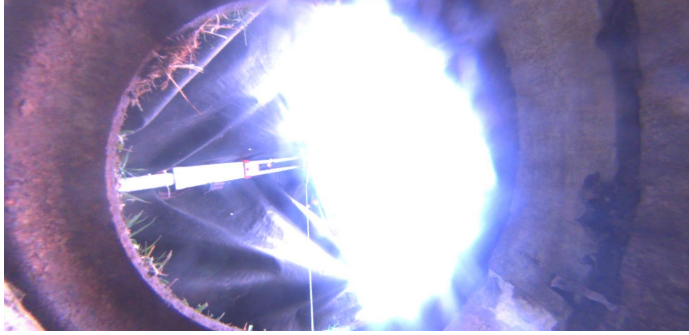
Code:	<b>MGO</b>
Description:	<b>General Observation</b>
Distance (ft):	<b>1.5</b>
Structural Grade:	<b>0</b>
O&M Grade:	<b>0</b>
Clock Start/From:	
Clock To:	
1st Value:	
2nd Value:	
Value Percent:	
Step:	<b>NO</b>
Remarks:	<b>UNDERSIDE OF FRAME</b>

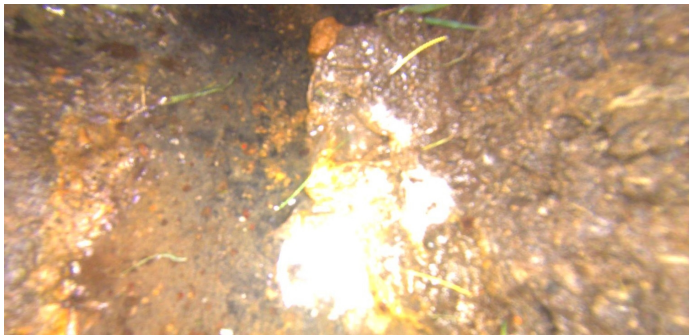
Code:	<b>MGO</b>
Description:	<b>General Observation</b>
Distance (ft):	<b>4.0</b>
Structural Grade:	<b>0</b>
O&M Grade:	<b>0</b>
Clock Start/From:	
Clock To:	
1st Value:	
2nd Value:	
Value Percent:	
Step:	<b>NO</b>
Remarks:	<b>END SURVEY</b>
