Manhole Inspection Report

Date:	05/09/2018	Weather:		Coding:	RZMACP
MH#:	M-905-036	Owner:	NA	Len. Surveyed:	3.0
P.O.#:		Surveyor:	Jen Costello	Rim to Invert:	3.0
Customer:		Cert. #:	U-907-5518	Wall Material:	Concrete (reinforced)

Street:	232' North of Hwy 130. 193' West o	Project:	Hobart, IN
City:	Hobart, IN	GPS Northing:	2910892.986
Location:		GPS Easting:	2910892.986
Drain Area:	Southeast	GPS Accuracy:	Sub-Meter
Cover Shape:	Circular	Evidence of Surcharge:	No
Cover Size:	18.0	Potential for Runoff:	None
Comments:

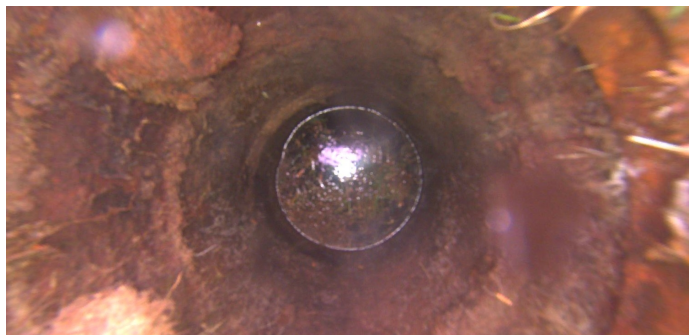
Code: **MGP**
Description: **General Photo**

Distance (ft): **.0**
Structural Grade: **0**
O&M Grade: **0**
Clock Start/From:
Clock To:
1st Value:
2nd Value:
Value Percent:
Step: **NO**
Remarks: **access mh**

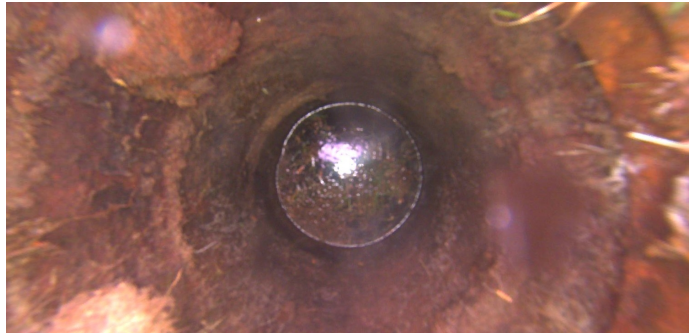
Code:	DAE
Description:	Deposits Attached Encrustation
Distance (ft):	.0
Structural Grade:	0
O&M Grade:	2
Clock Start/From:	10
Clock To:	
1st Value:	
2nd Value:	
Value Percent:	5.000
Step:	NO
Remarks:

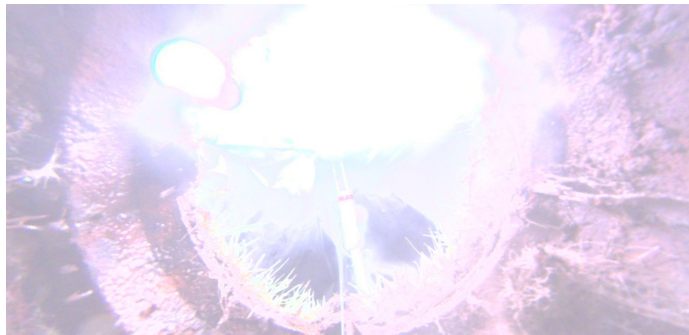
Code:	MGP
Description:	General Photo
Distance (ft):	1.4
Structural Grade:	0
O&M Grade:	0
Clock Start/From:	
Clock To:	
1st Value:	
2nd Value:	
Value Percent:	
Step:	NO
Remarks:	underside of frame

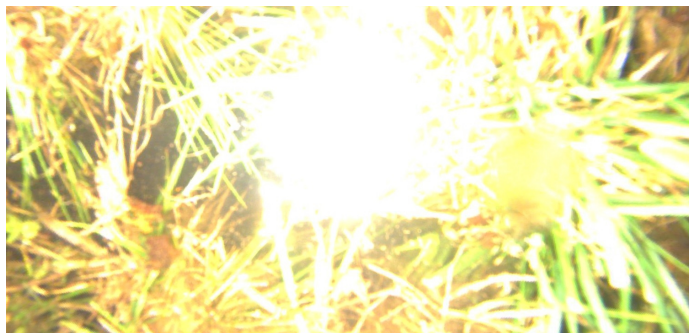
Code:	MSA
Description:	Abandoned Survey
Distance (ft):	3.0
Structural Grade:	0
O&M Grade:	0
Clock Start/From:	
Clock To:	
1st Value:	
2nd Value:	
Value Percent:	
Step:	NO
Remarks:	bench is submerged
