Manhole Inspection Report

Date:	05/09/2018	Weather:		Coding:	RZMACP
MH#:	M-905-037	Owner:	NA	Len. Surveyed:	2.9
P.O.#:		Surveyor:	Jen Costello	Rim to Invert:	2.9
Customer:		Cert. #:	U-907-5518	Wall Material:	Concrete (reinforced)

Street:	223' North of Hwy 130. 193' West o	Project:	Hobart, IN
City:	Hobart, IN	GPS Northing:	2910894.85
Location:		GPS Easting:	2910894.85
Drain Area:	Southeast	GPS Accuracy:	Sub-Meter
Cover Shape:	Circular	Evidence of Surcharge:	No
Cover Size:	18.0	Potential for Runoff:	None
Comments:

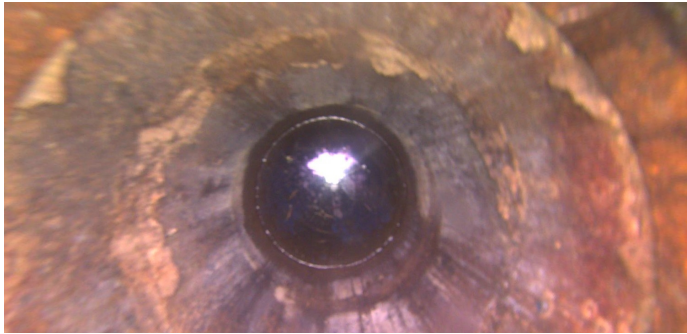
Code:	DAE
Description:	Deposits Attached Encrustation
Distance (ft):	.0
Structural Grade:	0
O&M Grade:	2
Clock Start/From:	12
Clock To:	12
1st Value:	
2nd Value:	
Value Percent:	5.000
Step:	NO
Remarks:

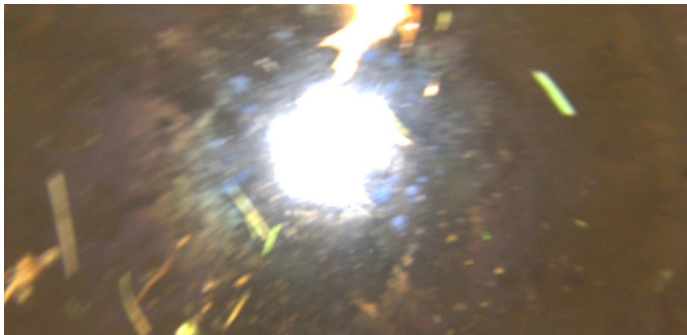
Code:	MSA
Description:	Abandoned Survey
Distance (ft):	2.9
Structural Grade:	0
O&M Grade:	0
Clock Start/From:	
Clock To:	
1st Value:	
2nd Value:	
Value Percent:	
Step:	NO
Remarks:	BENCH IS SUBMERGED
