Manhole Inspection Report

Date:	04/22/2018	Weather:		Coding:	RZMACP
MH#:	M-906-002	Owner:	NA	Len. Surveyed:	9.1
P.O.#:		Surveyor:	John Kuglmaier	Rim to Invert:	9.5
Customer:	8.7	Cert. #:	U-1215-07002349	Wall Material:	Concrete (reinforced)

Street:	10th St. 208' West of Sullivan Dr.	Project:	Hobart, IN
City:	Hobart, IN	GPS Northing:	0.0
Location:		GPS Easting:	0.0
Drain Area:	Southeast	GPS Accuracy:	Nearest Meter
Cover Shape:	Circular	Evidence of Surcharge:	Yes
Cover Size:	22.5	Potential for Runoff:	None
Comments:

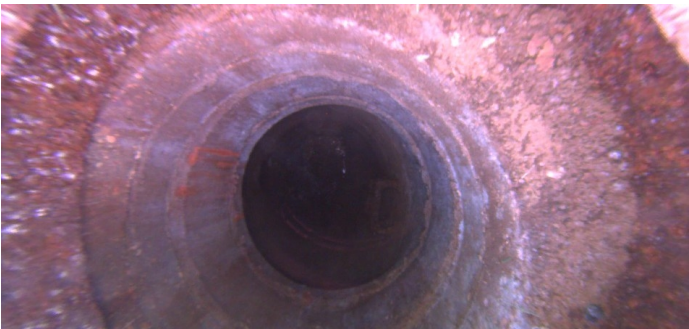
Code:
MGP

Description:
General Photo

Distance (ft):
.0

Structural Grade:
0

O&M Grade:
0

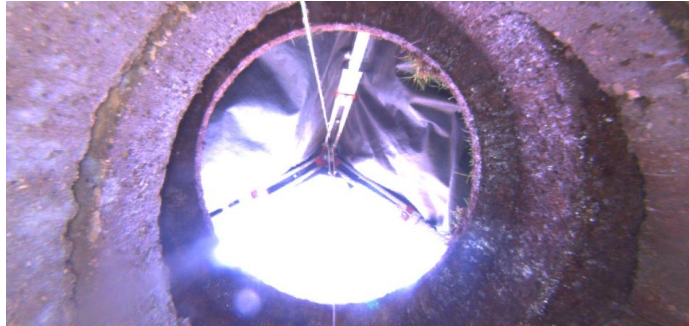
Code: **MGP**
Description: **General Photo**

Distance (ft): **2.7**
Structural Grade: **0**
O&M Grade: **0**
Clock Start/From:
Clock To:
1st Value:
2nd Value:
Value Percent:
Step: **NO**
Remarks:

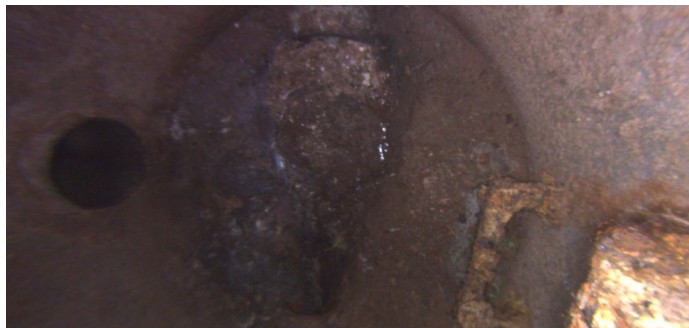
Code: **DAZ**
Description: **Deposits Attached Other**

Distance (ft): **7.0**
Structural Grade: **0**
O&M Grade: **3**
Clock Start/From: **12**
Clock To: **12**
1st Value:
2nd Value:
Value Percent: **15.000**
Step: **NO**
Remarks: **Mixed materials**

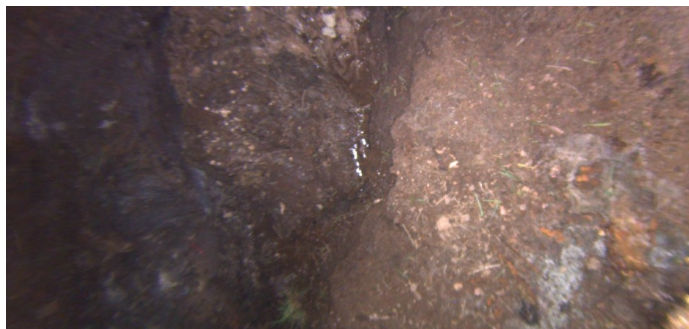
Code: **MGO**
Description: **General Observation**

Distance (ft): **8.6**
Structural Grade: **0**
O&M Grade: **0**
Clock Start/From:
Clock To:
1st Value:
2nd Value:
Value Percent:
Step: **NO**
Remarks: **Ins. Comp.**
