Manhole Inspection Report

Date:	04/22/2018	Weather:		Coding:	RZMACP
MH#:	M-906-005	Owner:	NA	Len. Surveyed:	6.4
P.O.#:		Surveyor:	John Kuglmaier	Rim to Invert:	6.3
Customer:	8.7	Cert. #:	U-1215-07002349	Wall Material:	Concrete (reinforced)

Street:	9th Pl. 342' West of Sullivan Dr.	Project:	Hobart, IN
City:	Hobart, IN	GPS Northing:	0.0
Location:		GPS Easting:	0.0
Drain Area:	Southeast	GPS Accuracy:	Nearest Meter
Cover Shape:	Circular	Evidence of Surcharge:	No
Cover Size:	22.5	Potential for Runoff:	None
Comments:

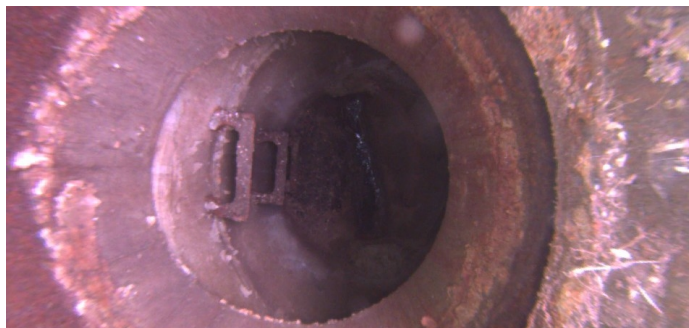
Code: **MGP**
Description: **General Photo**

Distance (ft): **.0**
Structural Grade: **0**
O&M Grade: **0**
Clock Start/From:
Clock To:
1st Value:
2nd Value:
Value Percent:
Step: **NO**
Remarks:

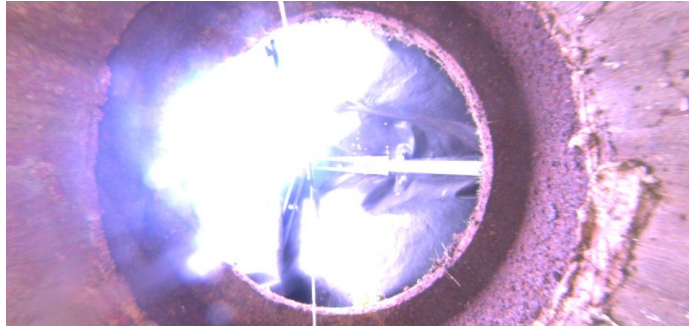
Code: **MGP**
Description: **General Photo**

Distance (ft): **2.7**
Structural Grade: **0**
O&M Grade: **0**
Clock Start/From:
Clock To:
1st Value:
2nd Value:
Value Percent:
Step: **NO**
Remarks:

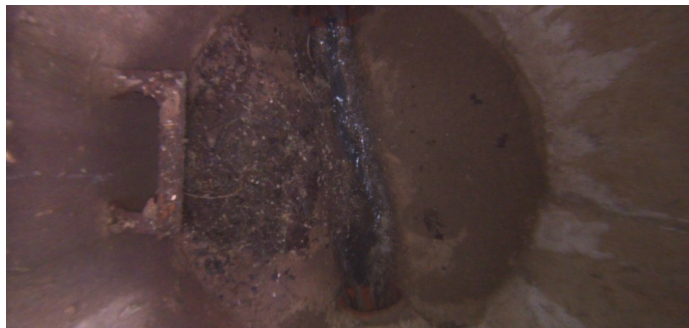
Code: **DAZ**
Description: **Deposits Attached Other**

Distance (ft): **3.5**
Structural Grade: **0**
O&M Grade: **2**
Clock Start/From: **12**
Clock To: **12**
1st Value:
2nd Value:
Value Percent: **5.000**
Step: **NO**
Remarks: **Mixed materials**

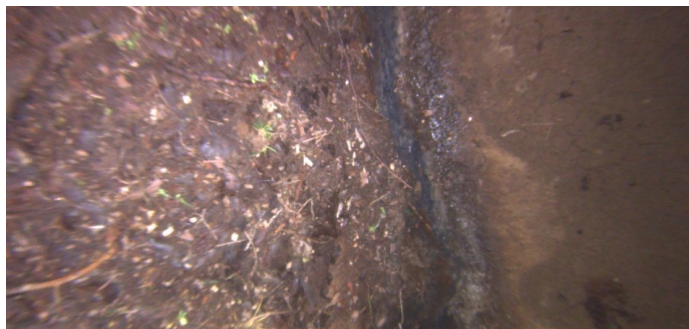
Code: **MGO**
Description: **General Observation**

Distance (ft): **5.5**
Structural Grade: **0**
O&M Grade: **0**
Clock Start/From:
Clock To:
1st Value:
2nd Value:
Value Percent:
Step: **NO**
Remarks: **Ins. Comp.**
