Manhole Inspection Report

Date:	04/22/2018	Weather:		Coding:	RZMACP
MH#:	M-906-006	Owner:	NA	Len. Surveyed:	7.5
P.O.#:		Surveyor:	John Kuglmaier	Rim to Invert:	7.5
Customer:	8.7	Cert. #:	U-1215-07002349	Wall Material:	Concrete (reinforced)

Street:	Intersection of Duck Cr. Ct. and 9th	Project:	Hobart, IN
City:	Hobart, IN	GPS Northing:	0.0
Location:		GPS Easting:	0.0
Drain Area:	Southeast	GPS Accuracy:	Nearest Meter
Cover Shape:	Circular	Evidence of Surcharge:	No
Cover Size:	22.5	Potential for Runoff:	None
Comments:

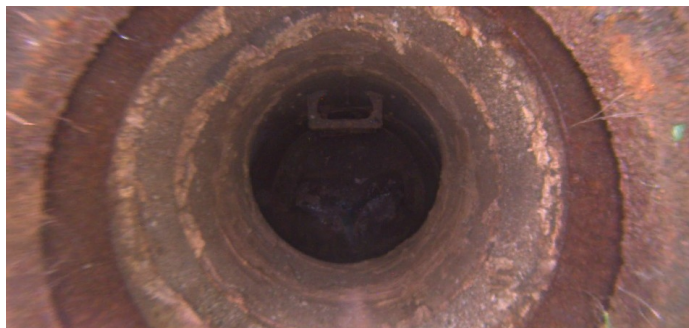
Code: **MGP**
Description: **General Photo**

Distance (ft): **.0**
Structural Grade: **0**
O&M Grade: **0**
Clock Start/From:
Clock To:
1st Value:
2nd Value:
Value Percent:
Step: **NO**
Remarks:

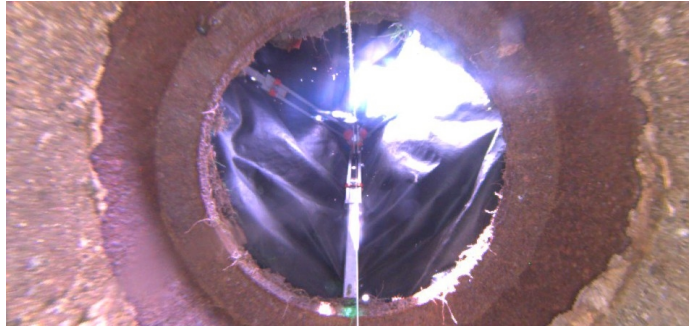
Code: **MGP**
Description: **General Photo**

Distance (ft): **2.7**
Structural Grade: **0**
O&M Grade: **0**
Clock Start/From:
Clock To:
1st Value:
2nd Value:
Value Percent:
Step: **NO**
Remarks:

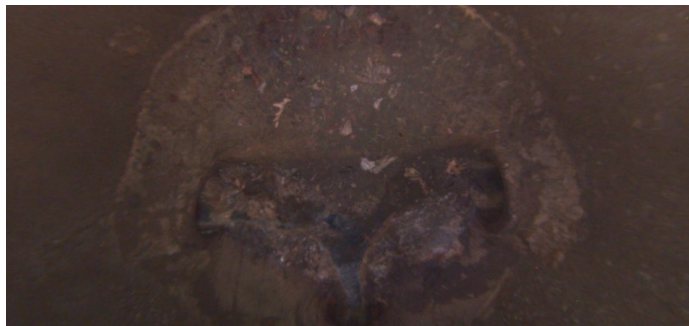
Code: **DAZ**
Description: **Deposits Attached Other**

Distance (ft): **5.4**
Structural Grade: **0**
O&M Grade: **2**
Clock Start/From: **12**
Clock To: **12**
1st Value:
2nd Value:
Value Percent: **5.000**
Step: **NO**
Remarks: **Mixed materials**

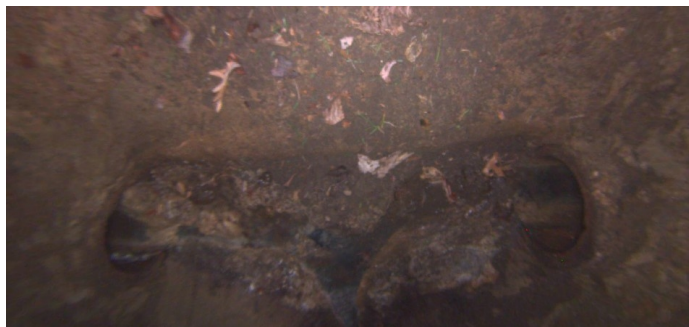
Code: **MGO**
Description: **General Observation**

Distance (ft): **6.3**
Structural Grade: **0**
O&M Grade: **0**
Clock Start/From:
Clock To:
1st Value:
2nd Value:
Value Percent:
Step: **NO**
Remarks: **Ins. Comp.**
