Manhole Inspection Report

Date:	04/22/2018	Weather:		Coding:	RZMACP
MH#:	M-906-008	Owner:	NA	Len. Surveyed:	13.4
P.O.#:		Surveyor:	John Kuglmaier	Rim to Invert:	14.0
Customer:	8.7	Cert. #:	U-1215-07002349	Wall Material:	Concrete (reinforced)

Street:	Sullivan Dr. 210' South of 9th Pl.	Project:	Hobart, IN
City:	Hobart, IN	GPS Northing:	0.0
Location:		GPS Easting:	0.0
Drain Area:	Southeast	GPS Accuracy:	Nearest Meter
Cover Shape:	Circular	Evidence of Surcharge:	No
Cover Size:	22.5	Potential for Runoff:	None
Comments:

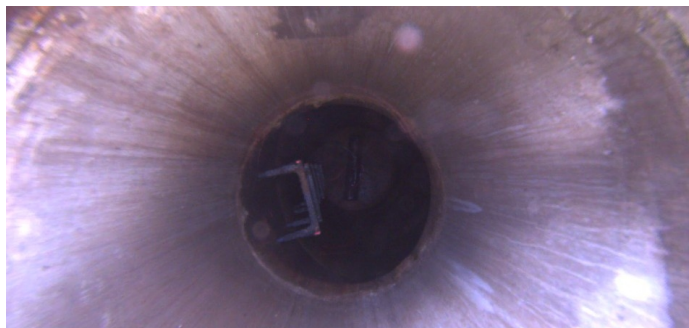
Code: **MGP**
Description: **General Photo**

Distance (ft): **.0**
Structural Grade: **0**
O&M Grade: **0**
Clock Start/From:
Clock To:
1st Value:
2nd Value:
Value Percent:
Step: **NO**
Remarks:

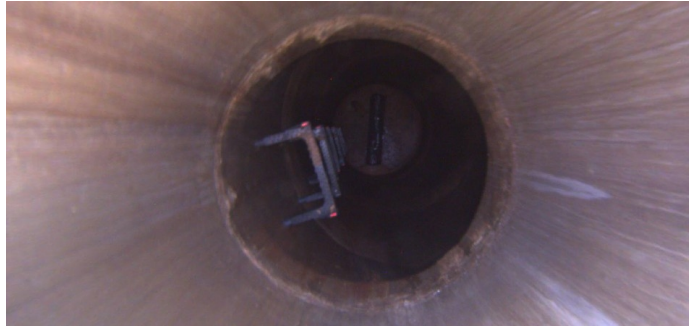
Code: **IS**
Description: **Infil Stain**

Distance (ft): **.9**
Structural Grade: **0**
O&M Grade: **0**
Clock Start/From: **12**
Clock To: **12**
1st Value:
2nd Value:
Value Percent:
Step: **NO**
Remarks:

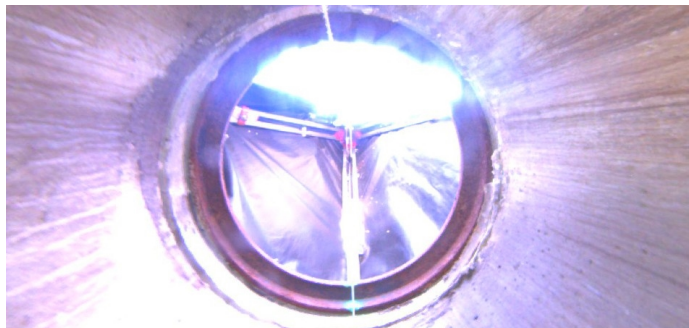
Code: **MGP**
Description: **General Photo**

Distance (ft): **2.6**
Structural Grade: **0**
O&M Grade: **0**
Clock Start/From:
Clock To:
1st Value:
2nd Value:
Value Percent:
Step: **NO**
Remarks:

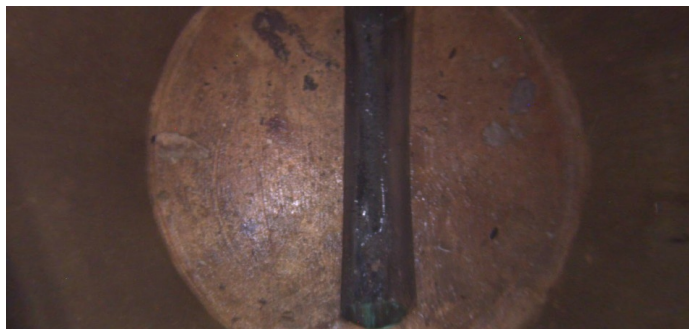
Code: **MGO**
Description: **General Observation**

Distance (ft): **11.5**
Structural Grade: **0**
O&M Grade: **0**
Clock Start/From:
Clock To:
1st Value:
2nd Value:
Value Percent:
Step: **NO**
Remarks: **Ins. Comp.**
