Manhole Inspection Report

Date:	04/22/2018	Weather:		Coding:	RZMACP
MH#:	M-906-013	Owner:	NA	Len. Surveyed:	6.3
P.O.#:		Surveyor:	John Kuglmaier	Rim to Invert:	6.5
Customer:	8.7	Cert. #:	U-1215-07002349	Wall Material:	Concrete (reinforced)

Street:	10th St. 707' West of Duck Cr. Ct.	Project:	Hobart, IN
City:	Hobart, IN	GPS Northing:	0.0
Location:		GPS Easting:	0.0
Drain Area:	Southeast	GPS Accuracy:	Nearest Meter
Cover Shape:	Circular	Evidence of Surcharge:	Yes
Cover Size:	22.5	Potential for Runoff:	None
Comments:

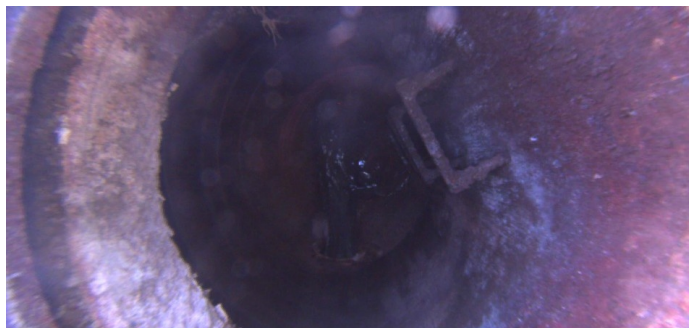
Code: **MGP**
 Description: **General Photo**

Distance (ft): **.0**
 Structural Grade: **0**
 O&M Grade: **0**
 Clock Start/From:
 Clock To:
 1st Value:
 2nd Value:
 Value Percent:
 Step: **NO**
 Remarks:

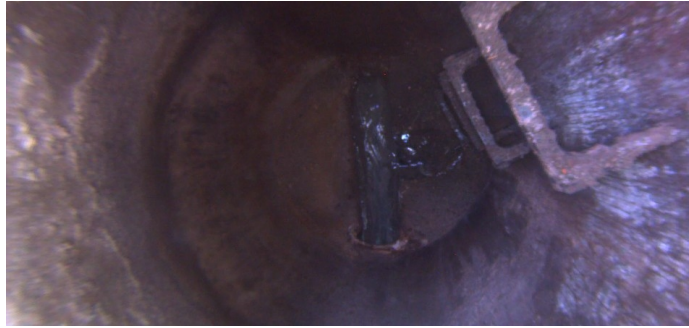
Code: **IS**
Description: **Infil Stain**

Distance (ft): **.8**
Structural Grade: **0**
O&M Grade: **0**
Clock Start/From: **7**
Clock To: **2**
1st Value:
2nd Value:
Value Percent:
Step: **NO**
Remarks:

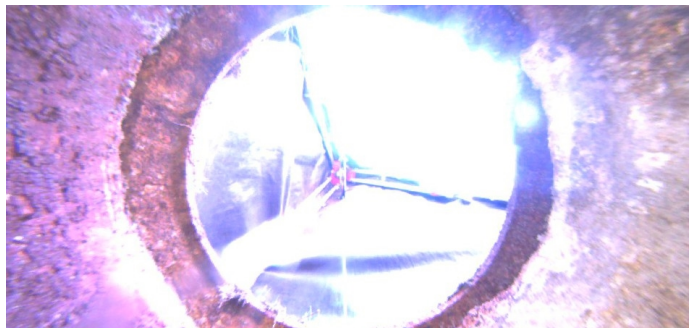
Code: **MGP**
Description: **General Photo**

Distance (ft): **2.3**
Structural Grade: **0**
O&M Grade: **0**
Clock Start/From:
Clock To:
1st Value:
2nd Value:
Value Percent:
Step: **NO**
Remarks:

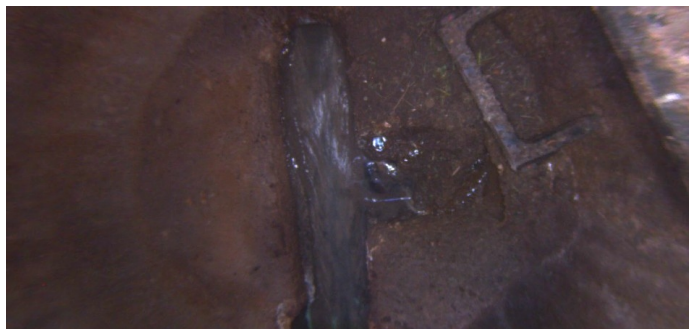
Code: **DAZ**
Description: **Deposits Attached Other**

Distance (ft): **3.8**
Structural Grade: **0**
O&M Grade: **3**
Clock Start/From: **12**
Clock To: **12**
1st Value:
2nd Value:
Value Percent: **15.000**
Step: **NO**
Remarks: **Mixed materials**

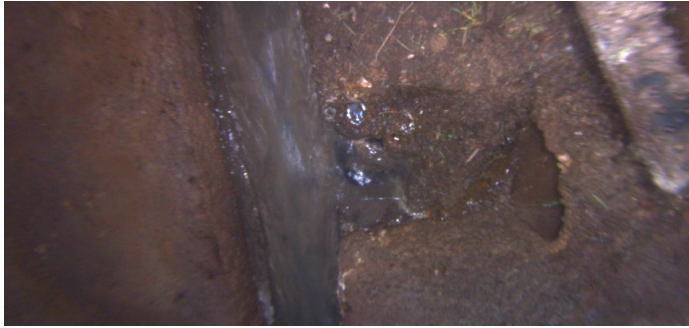
Code:	MGO
Description:	General Observation
Distance (ft):	4.9
Structural Grade:	0
O&M Grade:	0
Clock Start/From:	
Clock To:	
1st Value:	
2nd Value:	
Value Percent:	
Step:	NO
Remarks:	Ins. Comp.
