Manhole Inspection Report

Date:	04/22/2018	Weather:		Coding:	RZMACP
MH#:	M-906-014	Owner:	NA	Len. Surveyed:	9.1
P.O.#:		Surveyor:	Jen Costello	Rim to Invert:	9.5
Customer:	8.7	Cert. #:	U-907-5518	Wall Material:	Concrete (reinforced)

Street:	10th St. 631' East of Hobart Rd.	Project:	Hobart, IN
City:	Hobart, IN	GPS Northing:	0.0
Location:		GPS Easting:	0.0
Drain Area:	Southeast	GPS Accuracy:	Nearest Meter
Cover Shape:	Circular	Evidence of Surcharge:	No
Cover Size:	22.5	Potential for Runoff:	None
Comments:

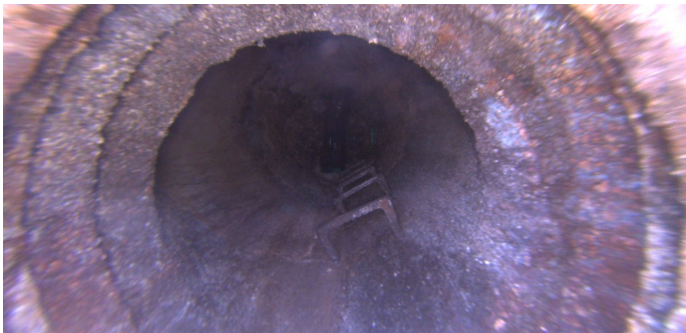
Code:	MGO
Description:	General Observation

Distance (ft):	.0
Structural Grade:	0
O&M Grade:	0
Clock Start/From:	
Clock To:	
1st Value:	
2nd Value:	
Value Percent:	
Step:	NO
Remarks:	AC

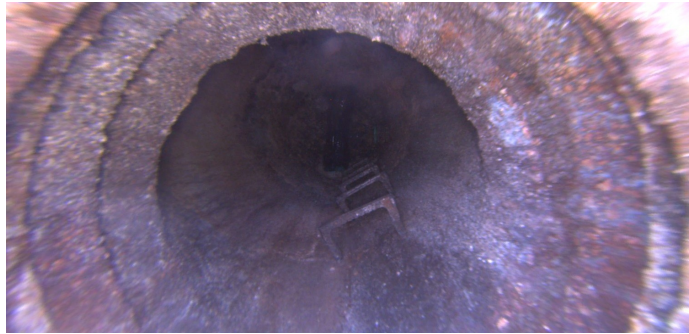
Code: **SAV**
Description: **Surface Aggregate Visible**

Distance (ft): **.0**
Structural Grade: **3**
O&M Grade: **0**
Clock Start/From: **12**
Clock To: **12**
1st Value:
2nd Value:
Value Percent:
Step: **NO**
Remarks:

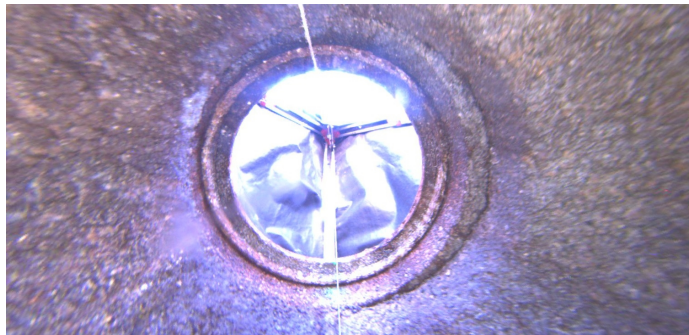
Code: **MGP**
Description: **General Photo**

Distance (ft): **2.4**
Structural Grade: **0**
O&M Grade: **0**
Clock Start/From:
Clock To:
1st Value:
2nd Value:
Value Percent:
Step: **NO**
Remarks: **UNDERSIDE OF FRAME**

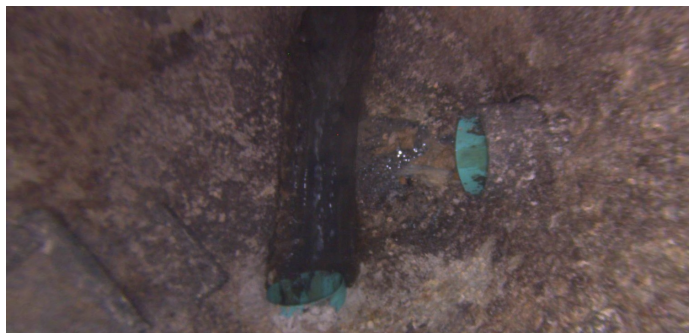
Code: **SAP**
Description: **Surface Aggregate Projecting**

Distance (ft): **5.9**
Structural Grade: **3**
O&M Grade: **0**
Clock Start/From: **12**
Clock To: **12**
1st Value:
2nd Value:
Value Percent:
Step: **NO**
Remarks:

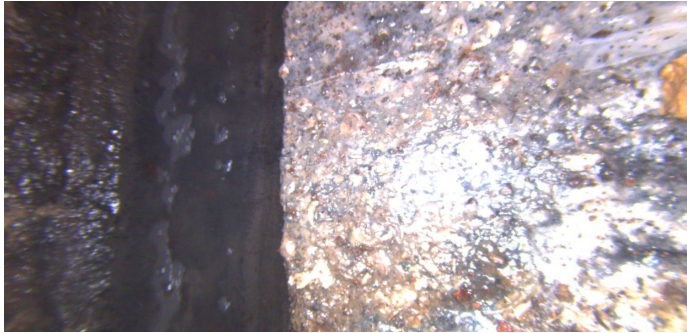
Code:	MGO
Description:	General Observation
Distance (ft):	9.1
Structural Grade:	0
O&M Grade:	0
Clock Start/From:	
Clock To:	
1st Value:	
2nd Value:	
Value Percent:	
Step:	NO
Remarks:	END SURVEY
